STROUD™ WATER
RESEARCH CENTER

Buffers-Part of Whole Farm Conservation

Models for Buffer Care Excellence

Different Models for Different Contexts

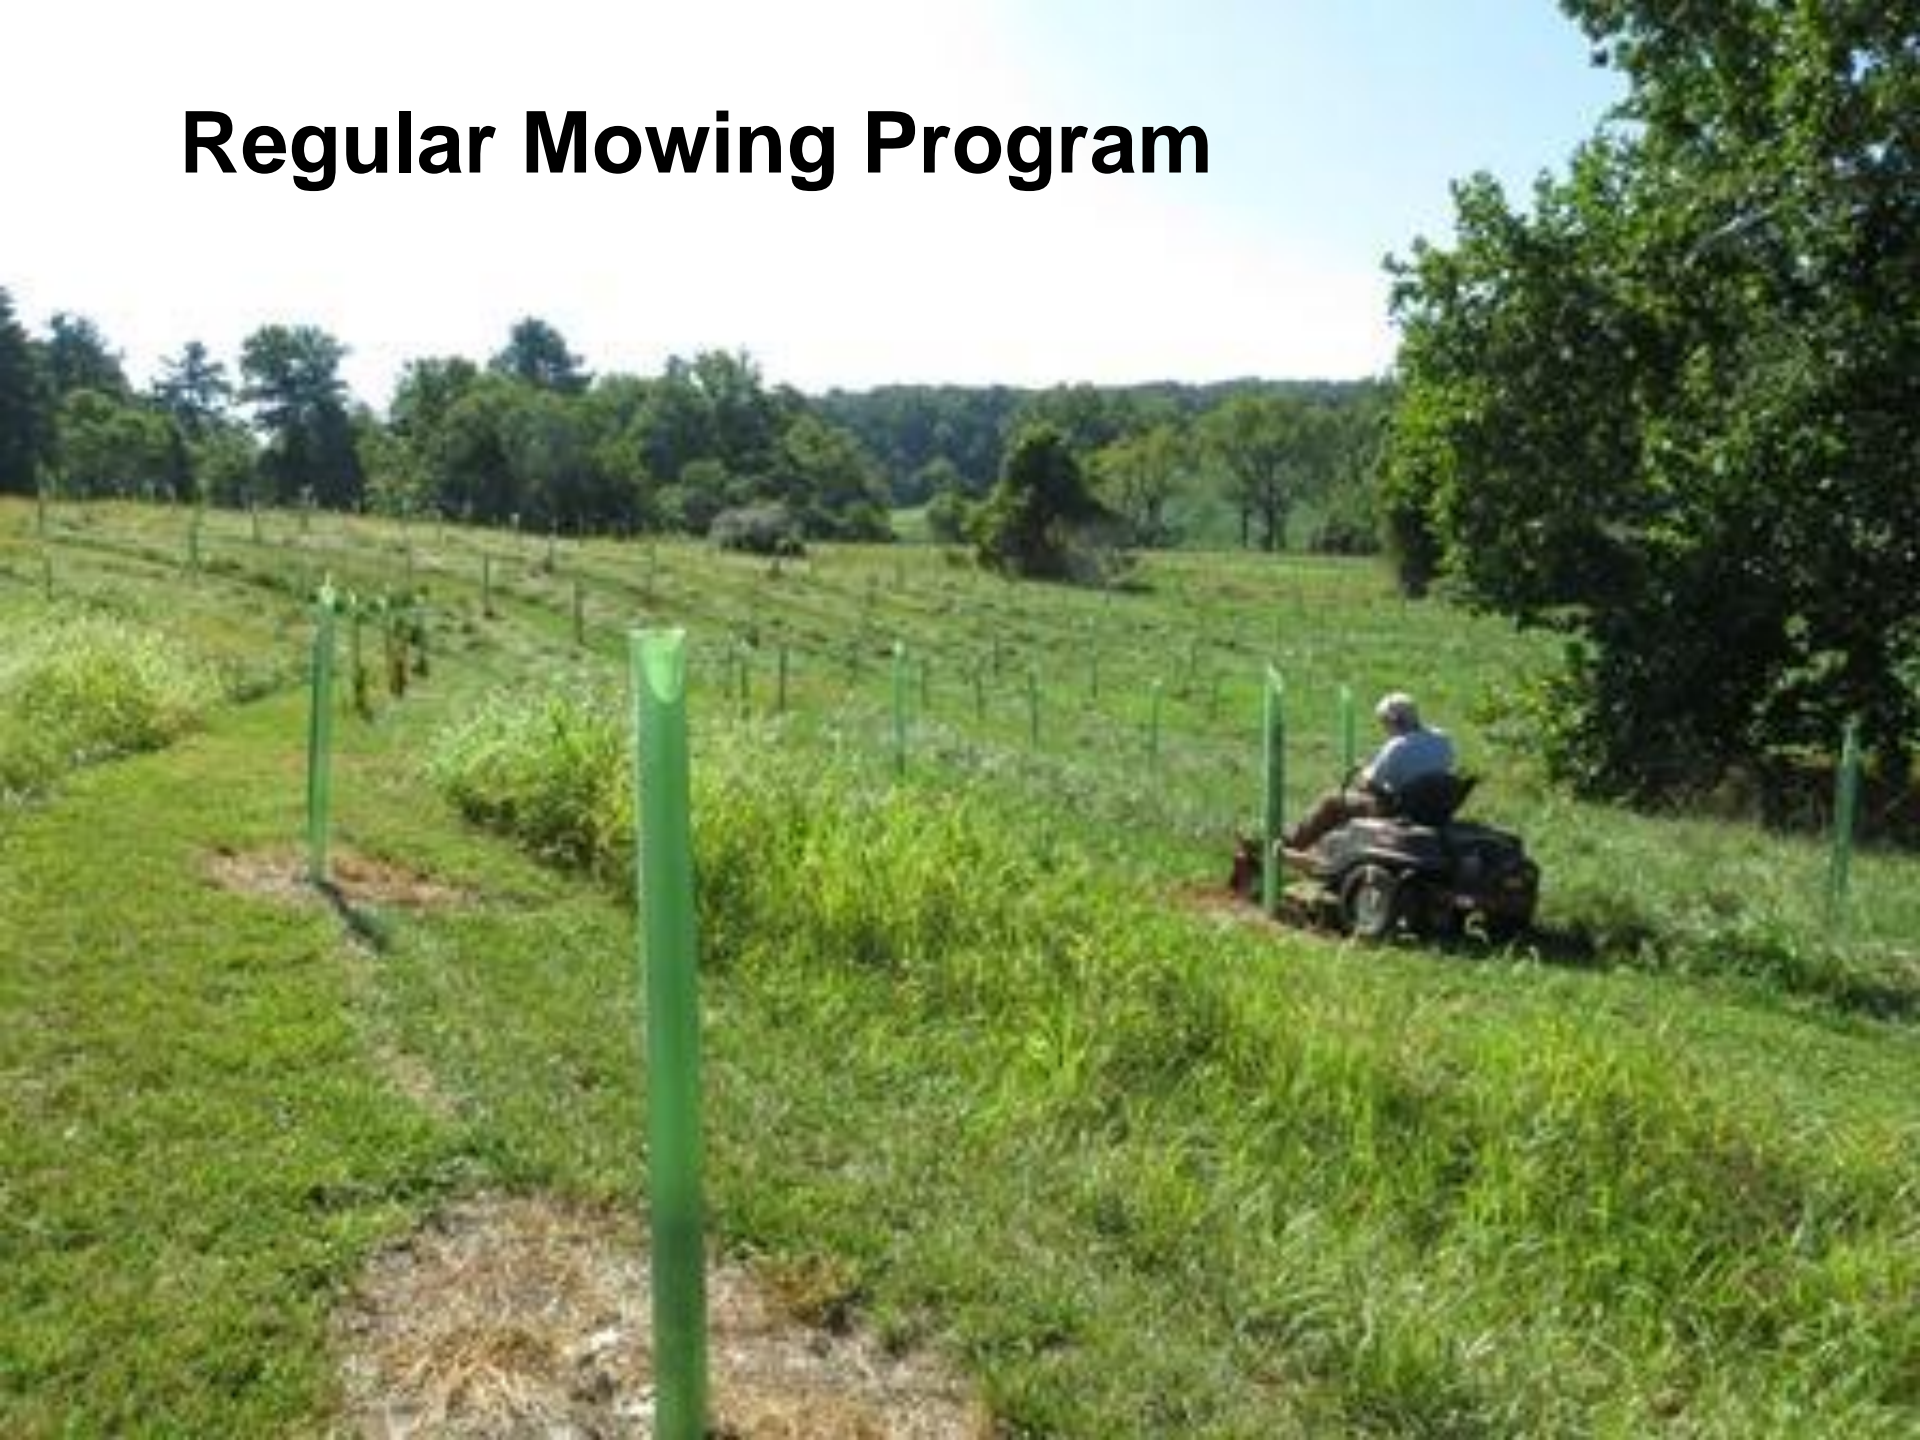
Regular Mowing Program

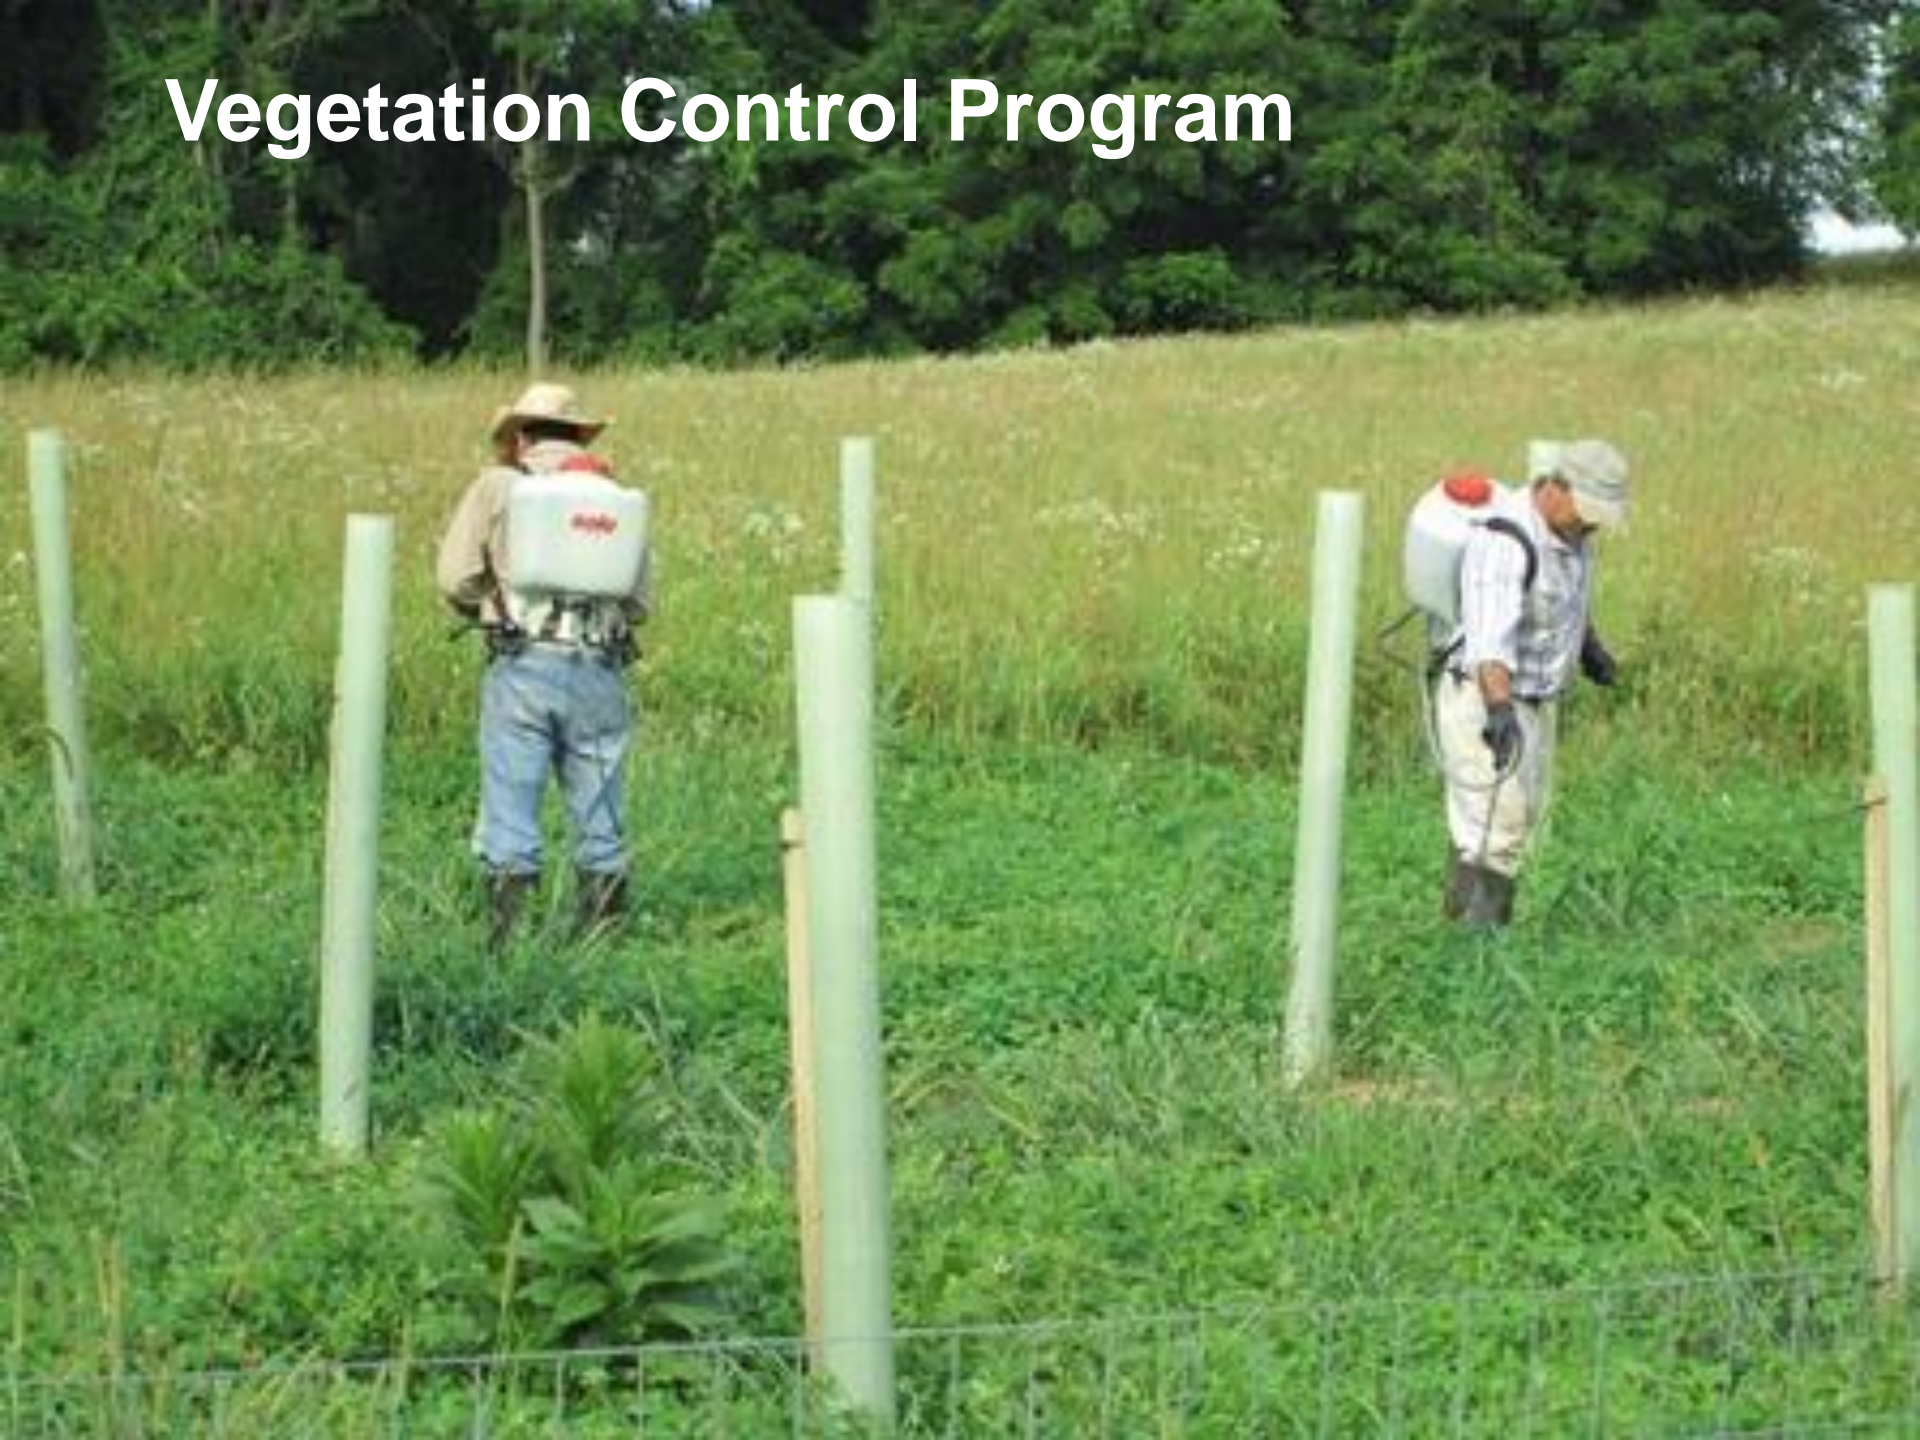
Vegetation Control Program

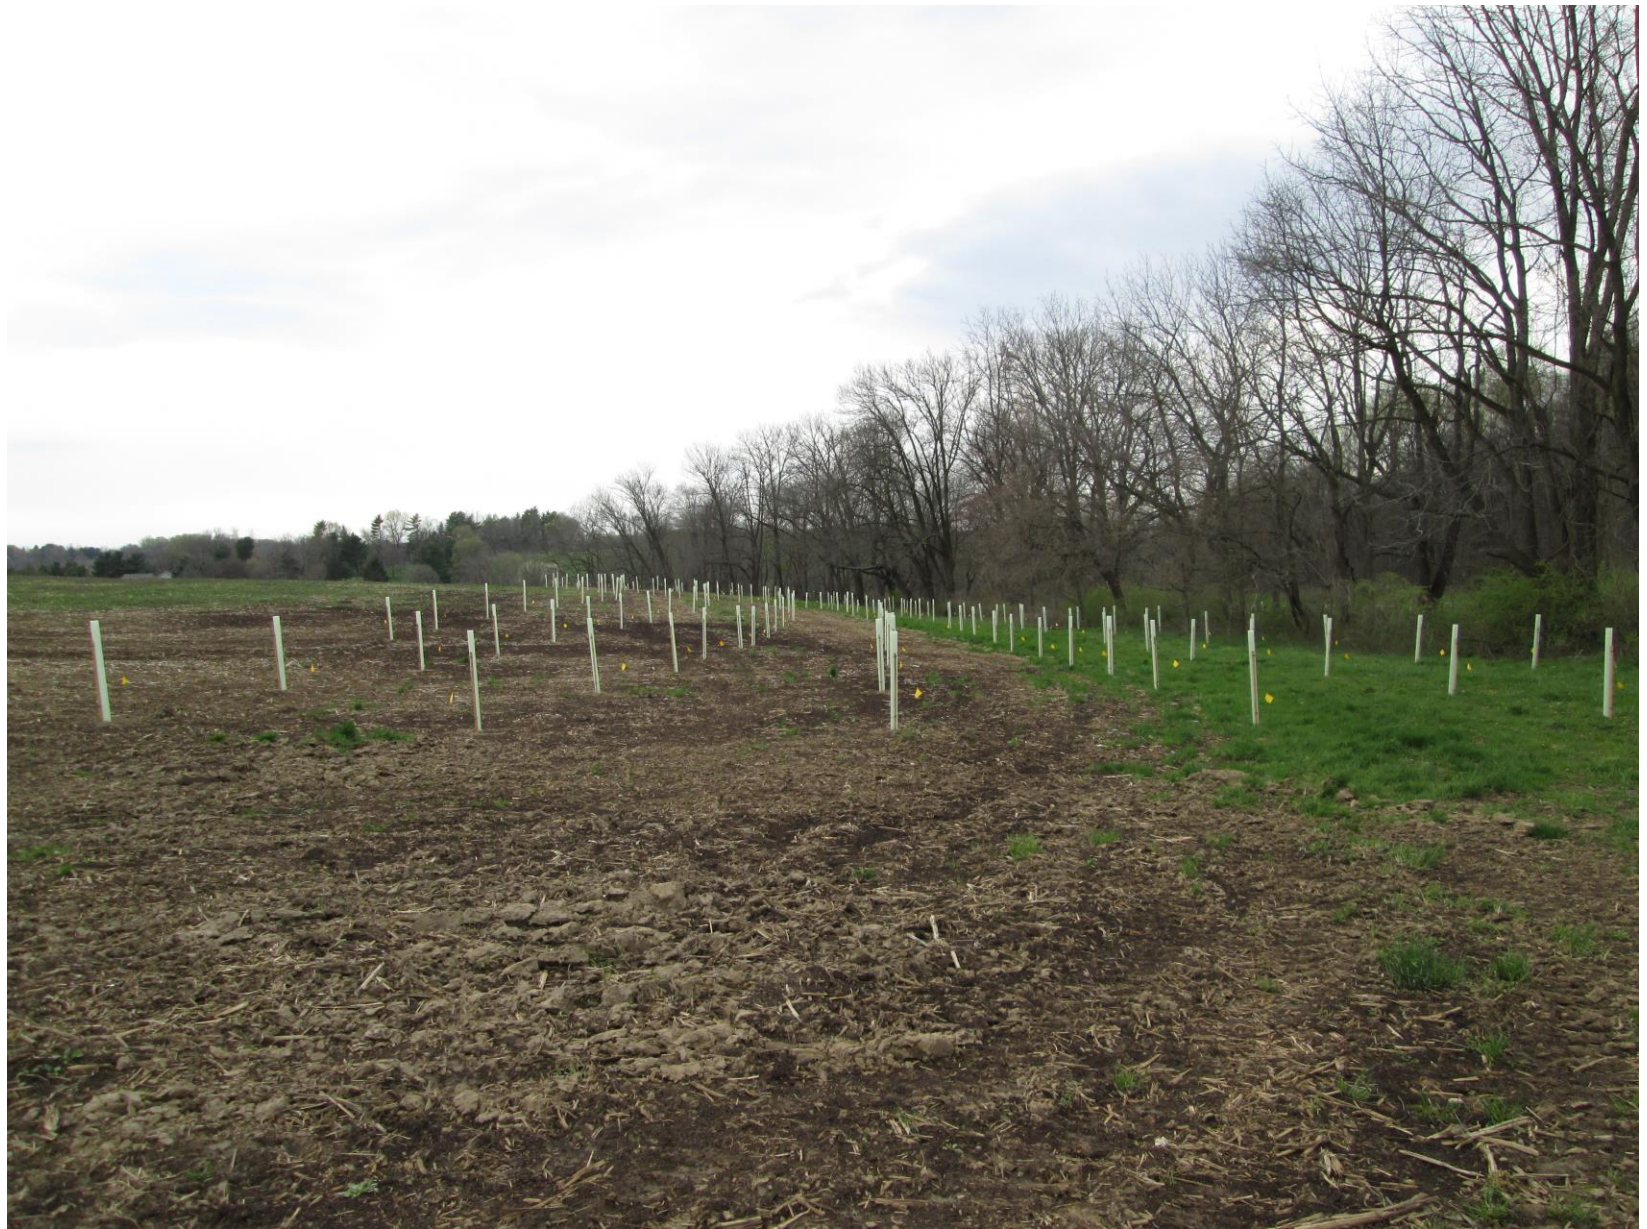
Shelter and Stake Management

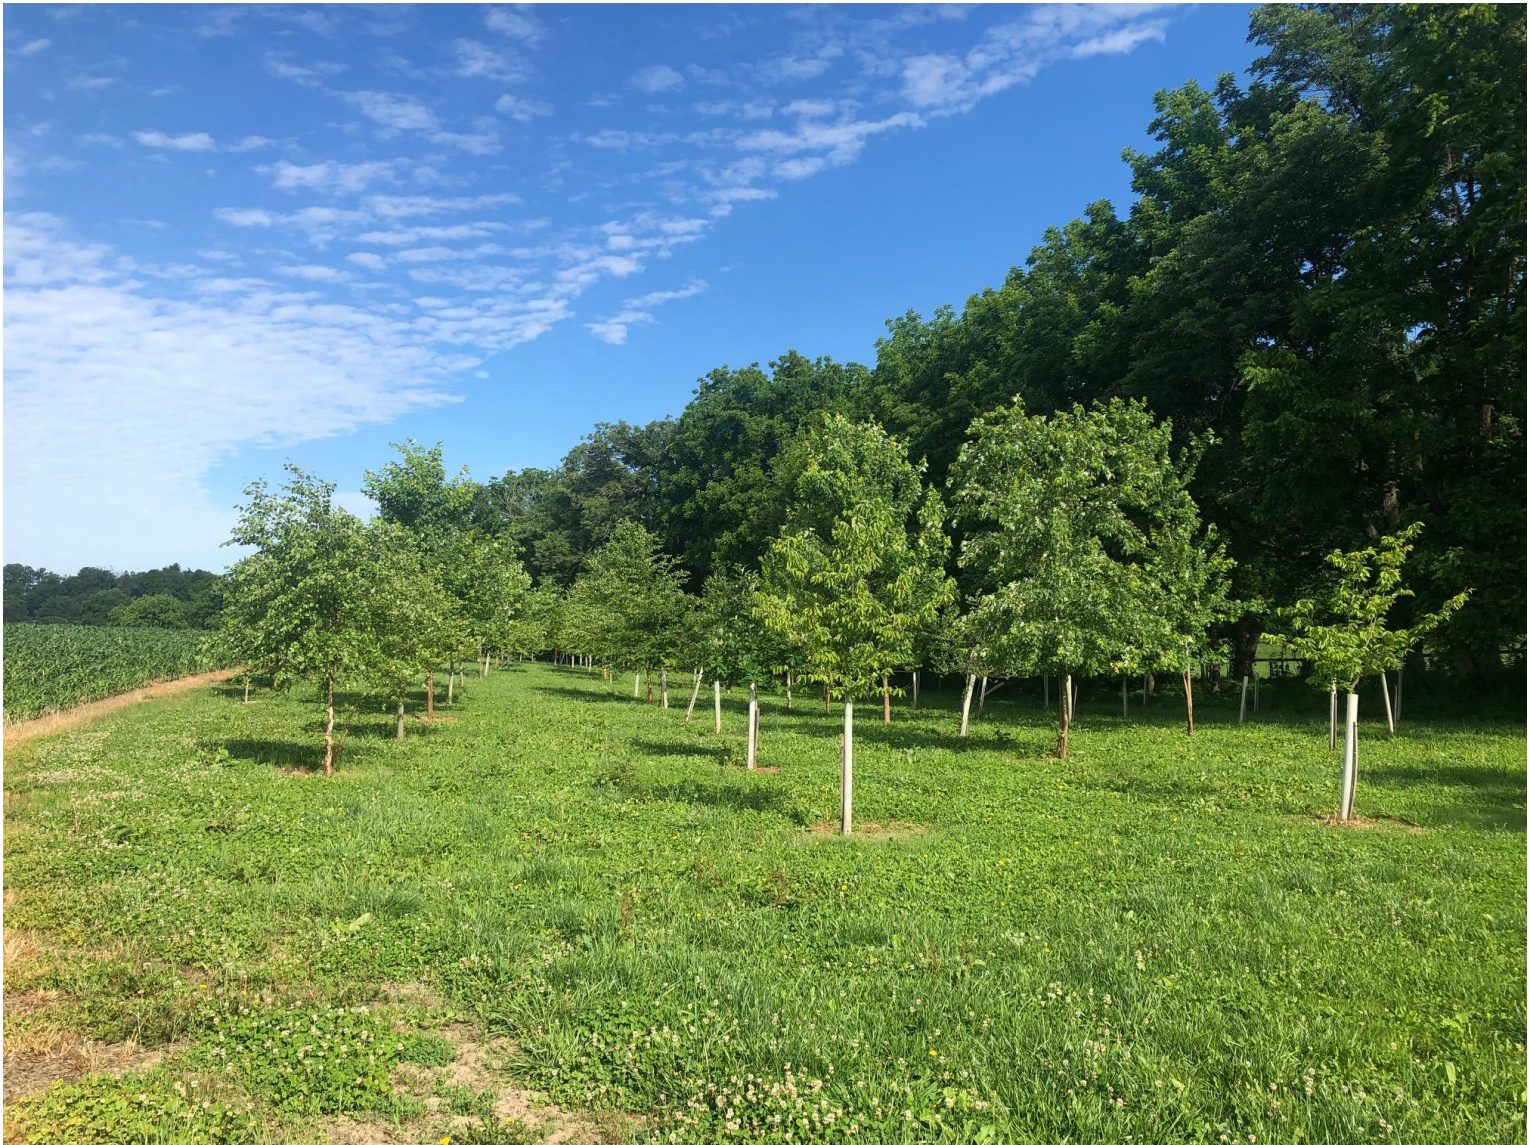
Chester Co Buffer in 2017

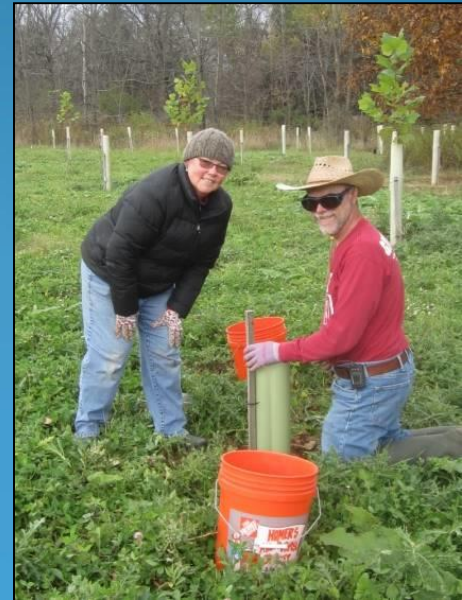
Tree shelter, stake & bird net maintenance

- Straighten shelters, seat shelters into soil
- Check shelters for damage, Evict mice ☹️
- Replace or remove bird nets
- Weed inside & around shelters
- Remove dead leaves from inside shelters
- Replace stakes or shelters when needed

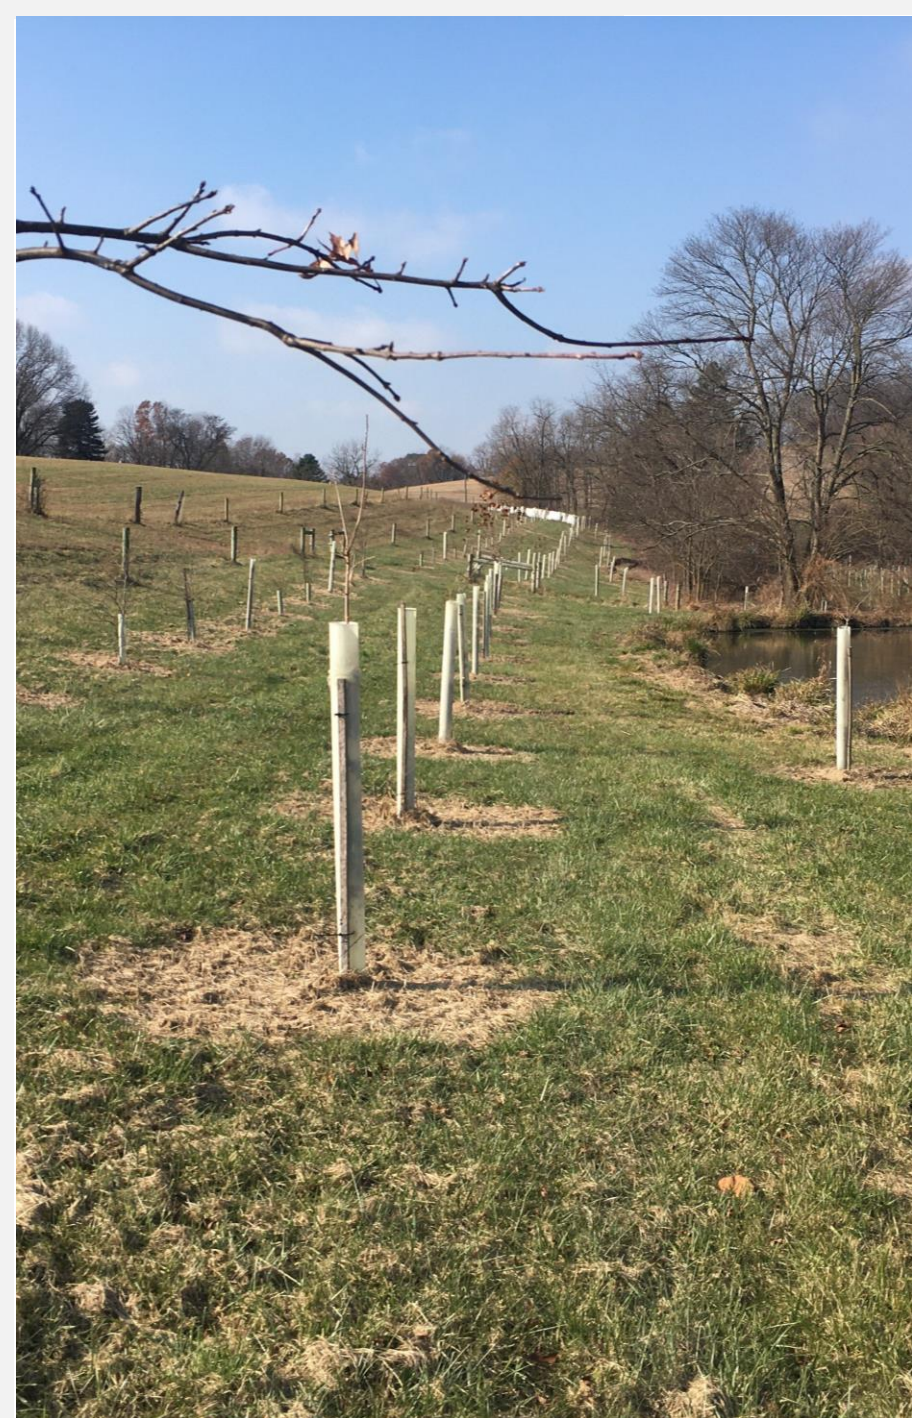
Buffer Checks and Trip Reports:

BUFFER CHECK TRIP REPORT					
NAME: _____					
DATE: <u>11/21/2019, 12/02/2019</u>					
LOCATION: <u>Buffer Fields 10 & 11 located at: _____</u>					
COMPLETED BY: <u>Kelsey Schwenk</u>					
	Field 10	Field 11		Field 10	Field 11

# of trees in plan:	<u>260</u>	<u>132</u>	# of shrubs in plan:	<u>68</u>	<u>36</u>
Live Trees:	<u>239</u>	<u>127</u>	Live Shrubs:	<u>66</u>	<u>34</u>
Dead Trees:	<u>21</u>	<u>5</u>	Dead Shrub:	<u>2</u>	<u>2</u>
% Survival:	<u>91.9%</u>	<u>96.2%</u>	% Survival:	<u>97.1%</u>	<u>94.4%</u>
Maintenance Task Needed by Operator:					
Yes	Invasive Species Management	List Species Found:	Invasives do not appear to be a significant problem in either buffer field. In total, 8 tree tubes contained oriental bittersweet, and 8 tree tubes contained multiflora rose.		
< 5	Tree tubes not in the ground	Notes:	Tree tubes and stakes are well maintained. Leaning tubes were <u>realigned and restaked as necessary.</u>		
< 5	Tree Tubes leaning	Notes:	Tree tubes and stakes are well maintained. Leaning tubes were <u>realigned and restaked as necessary.</u>		
Yes	Bird Net Maintenance	Notes:	Remove bird nets as necessary with tree growth. Nets should be removed before tree emerges from tube protector as nets can <u>cause tree growth deformation.</u>

No	Herbicide Spray	Notes:	A recent herbicide spray was evidenced by brown spray lines <u>across tree rows.</u>		
No	Mowing	Notes:	<u>It appears buffer fields were mowed in Fall 2019.</u>		
Discussion with operator:	Brief discussion with _____ concerning his buffer. Overall, the buffer has been well maintained through regular herbicide applications and mowing practices (when possible, due to the standing water in both fields).				
Problems:	Overall, both fields have excellent survival. Most mortality was due to inundated planting areas where trees were unable to establish.				
Completed Task:	Removed select bird nets, restaked/realigned tree tubes as necessary, documented the condition of the buffer through photographs and marked all dead trees with yellow flagging.				
Next Steps:	Perform semiannual buffer check in Winter 2020..				
Notes:	Continue to monitor growth of invasive tree of heaven around buffer edge—some dead spotted lanternflies were observed during the most recent check. If possible, provide replant trees that are OBL and FACW for best establishment in inundated planting areas.

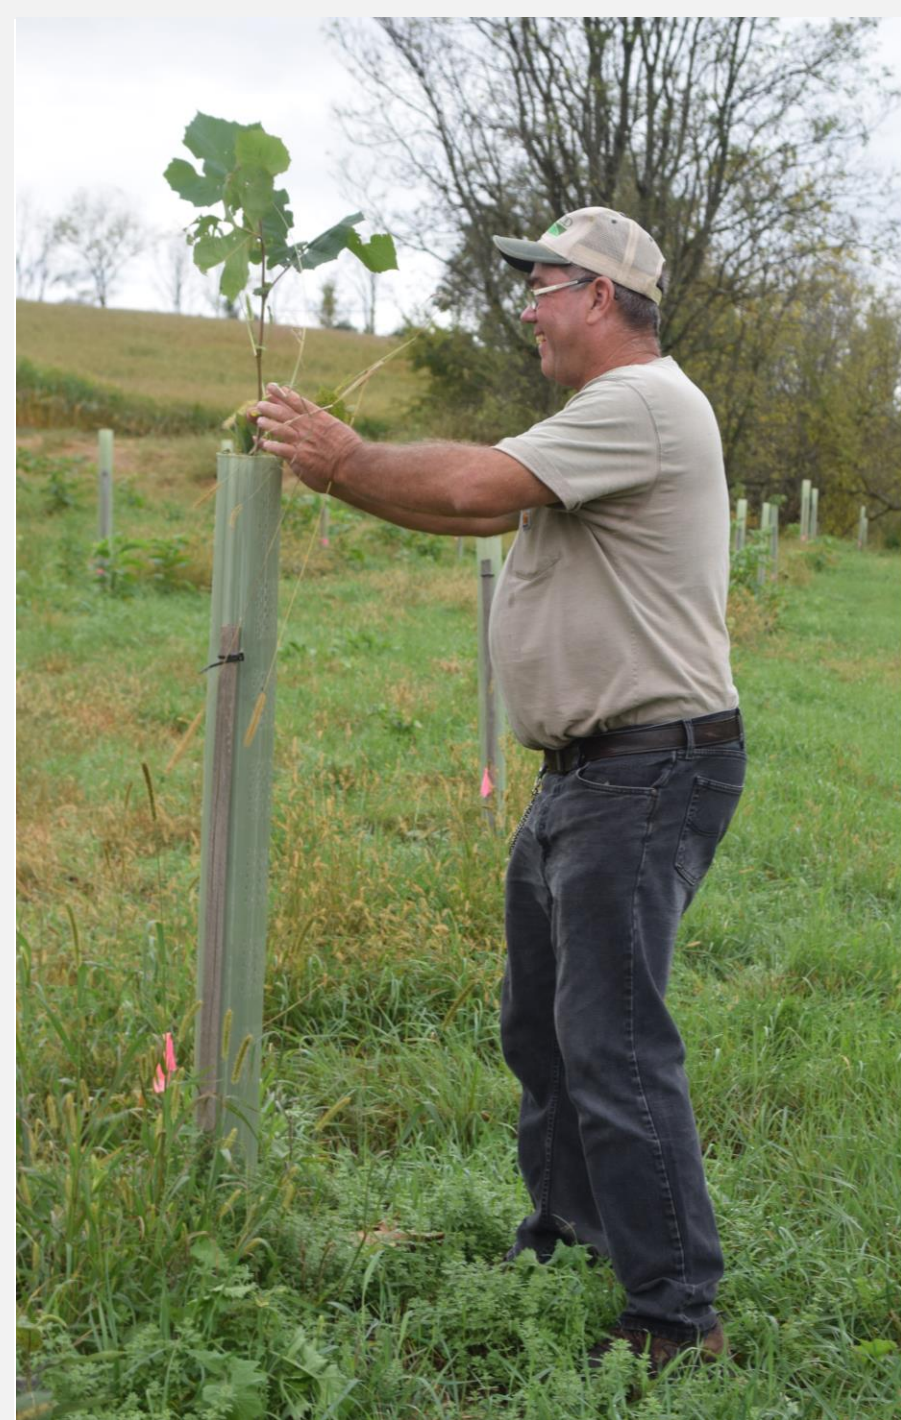
Fall 2019 Quarterly Buffer Summary:

Buffer Owner / Operator	Planting Month & Year	Most Recent Buffer Check Date	# Dead Trees	#Dead Shrubs	Total Trees in Plan	Total Shrubs in Plan	Tree Survival %	Shrub Survival %	# tubes w/ Oriental Bittersweet	# tubes w/ Multiflora Rose	% Tubes w/ Oriental Bittersweet	% Tubes w/ Multiflora Rose	Site Conditions: Wet, Dry, Wet/Dry
A	Apr 2018	11/20/19	0	0	353	88	100.0%	100.0%	2	0	0.5%	0.0%	Wet/Dry
B	Dec 2016	12/02/19	26	4	392	104	93.4%	96.2%	8	8	1.6%	1.6%	Wet/Dry
C	May 2016	12/05/19	25	8	445	111	94.4%	92.8%	0	8	0.0%	1.4%	Wet
D	May 2018	12/09/19	127	29	452	113	71.9%	74.3%	23	54	4.1%	9.6%	Wet/Dry
E	Oct 2018	10/23/19	10	0	220	60	95.5%	100.0%	0	0	0.0%	0.0%	Dry
F	Apr 2018	12/13/19	1	0	81	21	98.8%	100.0%	1	1	1.0%	1.0%	Dry
G	May 2017	09/16/19	236	68	836	209	71.8%	67.5%	24	0	2.3%	0.0%	Wet
H	Nov 2017	12/12/19	0	5	64	19	100.0%	73.7%	0	7	0.0%	8.4%	Wet/Dry
I	Dec 2015	12/17/19	17	4	640	160	97.3%	97.5%	4	11	0.5%	1.4%	Wet/Dry

J	Nov 2017	12/03/19	0	0	156	32	100.0%	100.0%	1	1	0.5%	0.5%	Wet
K	Nov 2016	11/13/19	0	0	1125	300	100.0%	100.0%	14	10	1.0%	0.7%	Dry
L	Oct 2016	11/19/19	24	0	700	175	96.6%	100.0%	40	22	4.6%	2.5%	Dry
M	Nov 2017	12/03/19	1	0	248	63	99.6%	100.0%	1	3	0.3%	1.0%	Dry
O	Nov 2018	10/04/19	117	21	1111	477	89.5%	95.6%	-	-	-	-	Dry
P	Oct 2016	12/11/19	2	1	450	100	99.6%	99.0%	2	1	0.4%	0.2%	Wet
Q	Mar 2016	01/13/20	20	0	185	0	89.2%	-	0	0	0.0%	0.0%	Wet/Dry
R	Mar 2016	11/04/19	22	0	256	64	91.4%	100.0%	8	5	2.5%	1.6%	Wet/Dry
AVERAGES							93.5%	88.0%			1.2%	1.9%

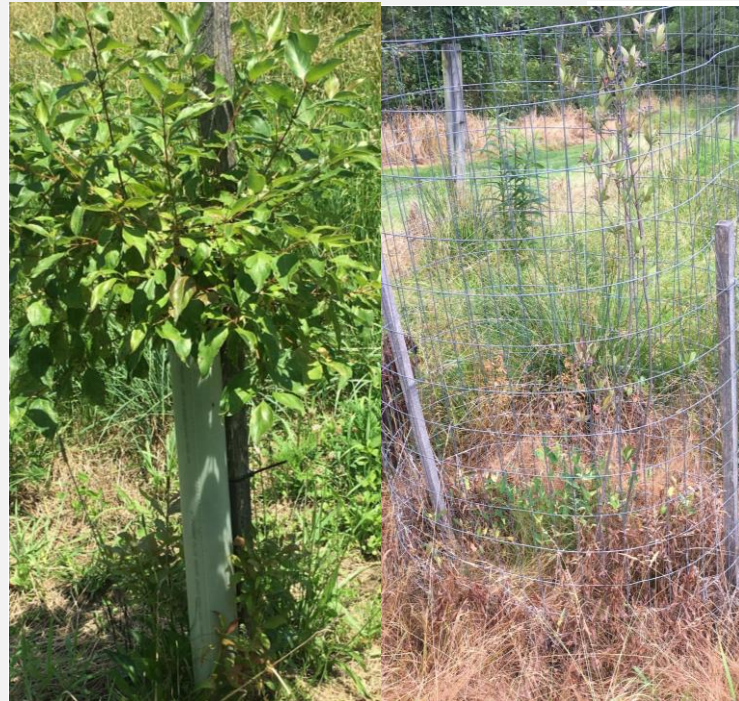
Ensuring Shrub Survival:

- Competitive growth around shrubs appears to cause most mortality/failure
- Gauge which shrub protection performs best
 - Need to collect quantitative data on success
 - Some qualitative observations below

Protection Device	PROS	CONS
Shrub shelter	<ul style="list-style-type: none"> • Ease of herbicide application 	<ul style="list-style-type: none"> • Not wide enough for shrub growth
Wire cage	<ul style="list-style-type: none"> • Complete tree protection 	<ul style="list-style-type: none"> • Uneven management, becomes overgrown • Can damage shrub during removal
Shrub shelter + wire cage	<ul style="list-style-type: none"> • Ease of herbicide application 	<ul style="list-style-type: none"> • Not wide enough for shrub growth • Can damage shrub during removal
