# **Nutrient Reduction Through Stream Restoration**

Graydon Dutcher  
Stream Program  
Delaware County Soil and Water Conservation District

**Estimating Nutrient Loads from Two Streambank Erosion Sites on  
the West Branch Delaware River, Delaware County, New York**

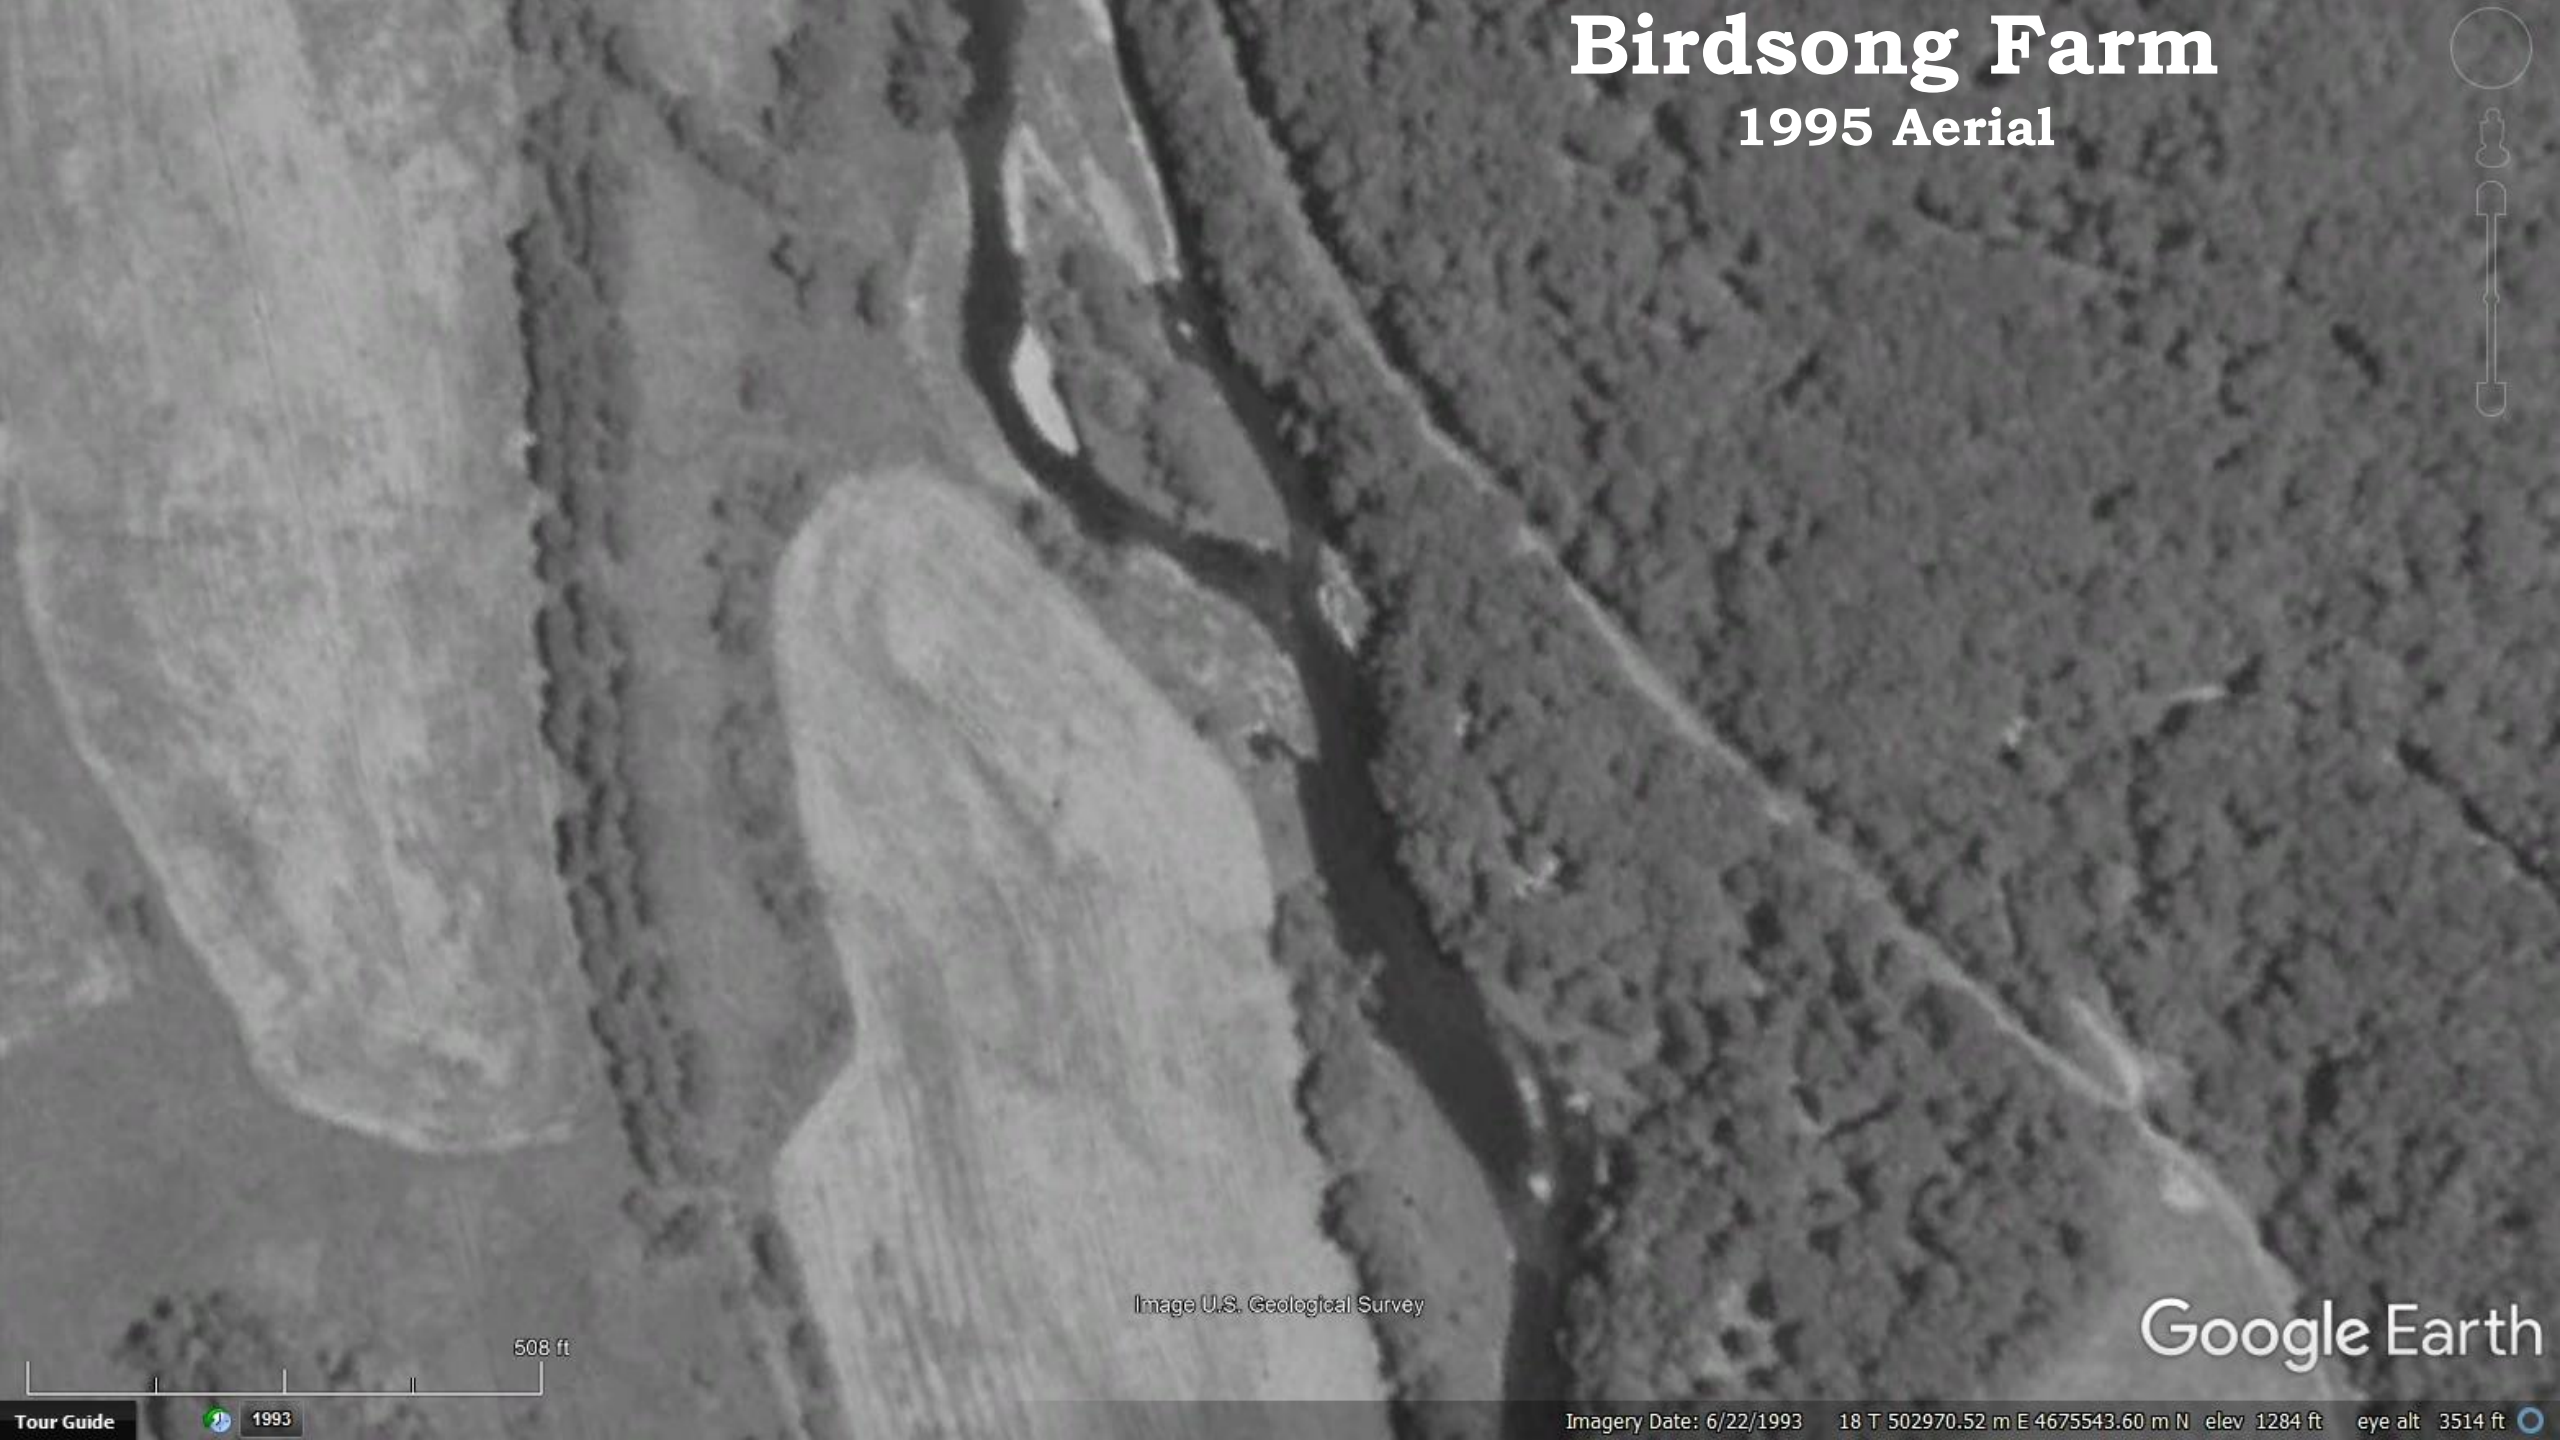
1995 Aerial

# Birdsong Farm

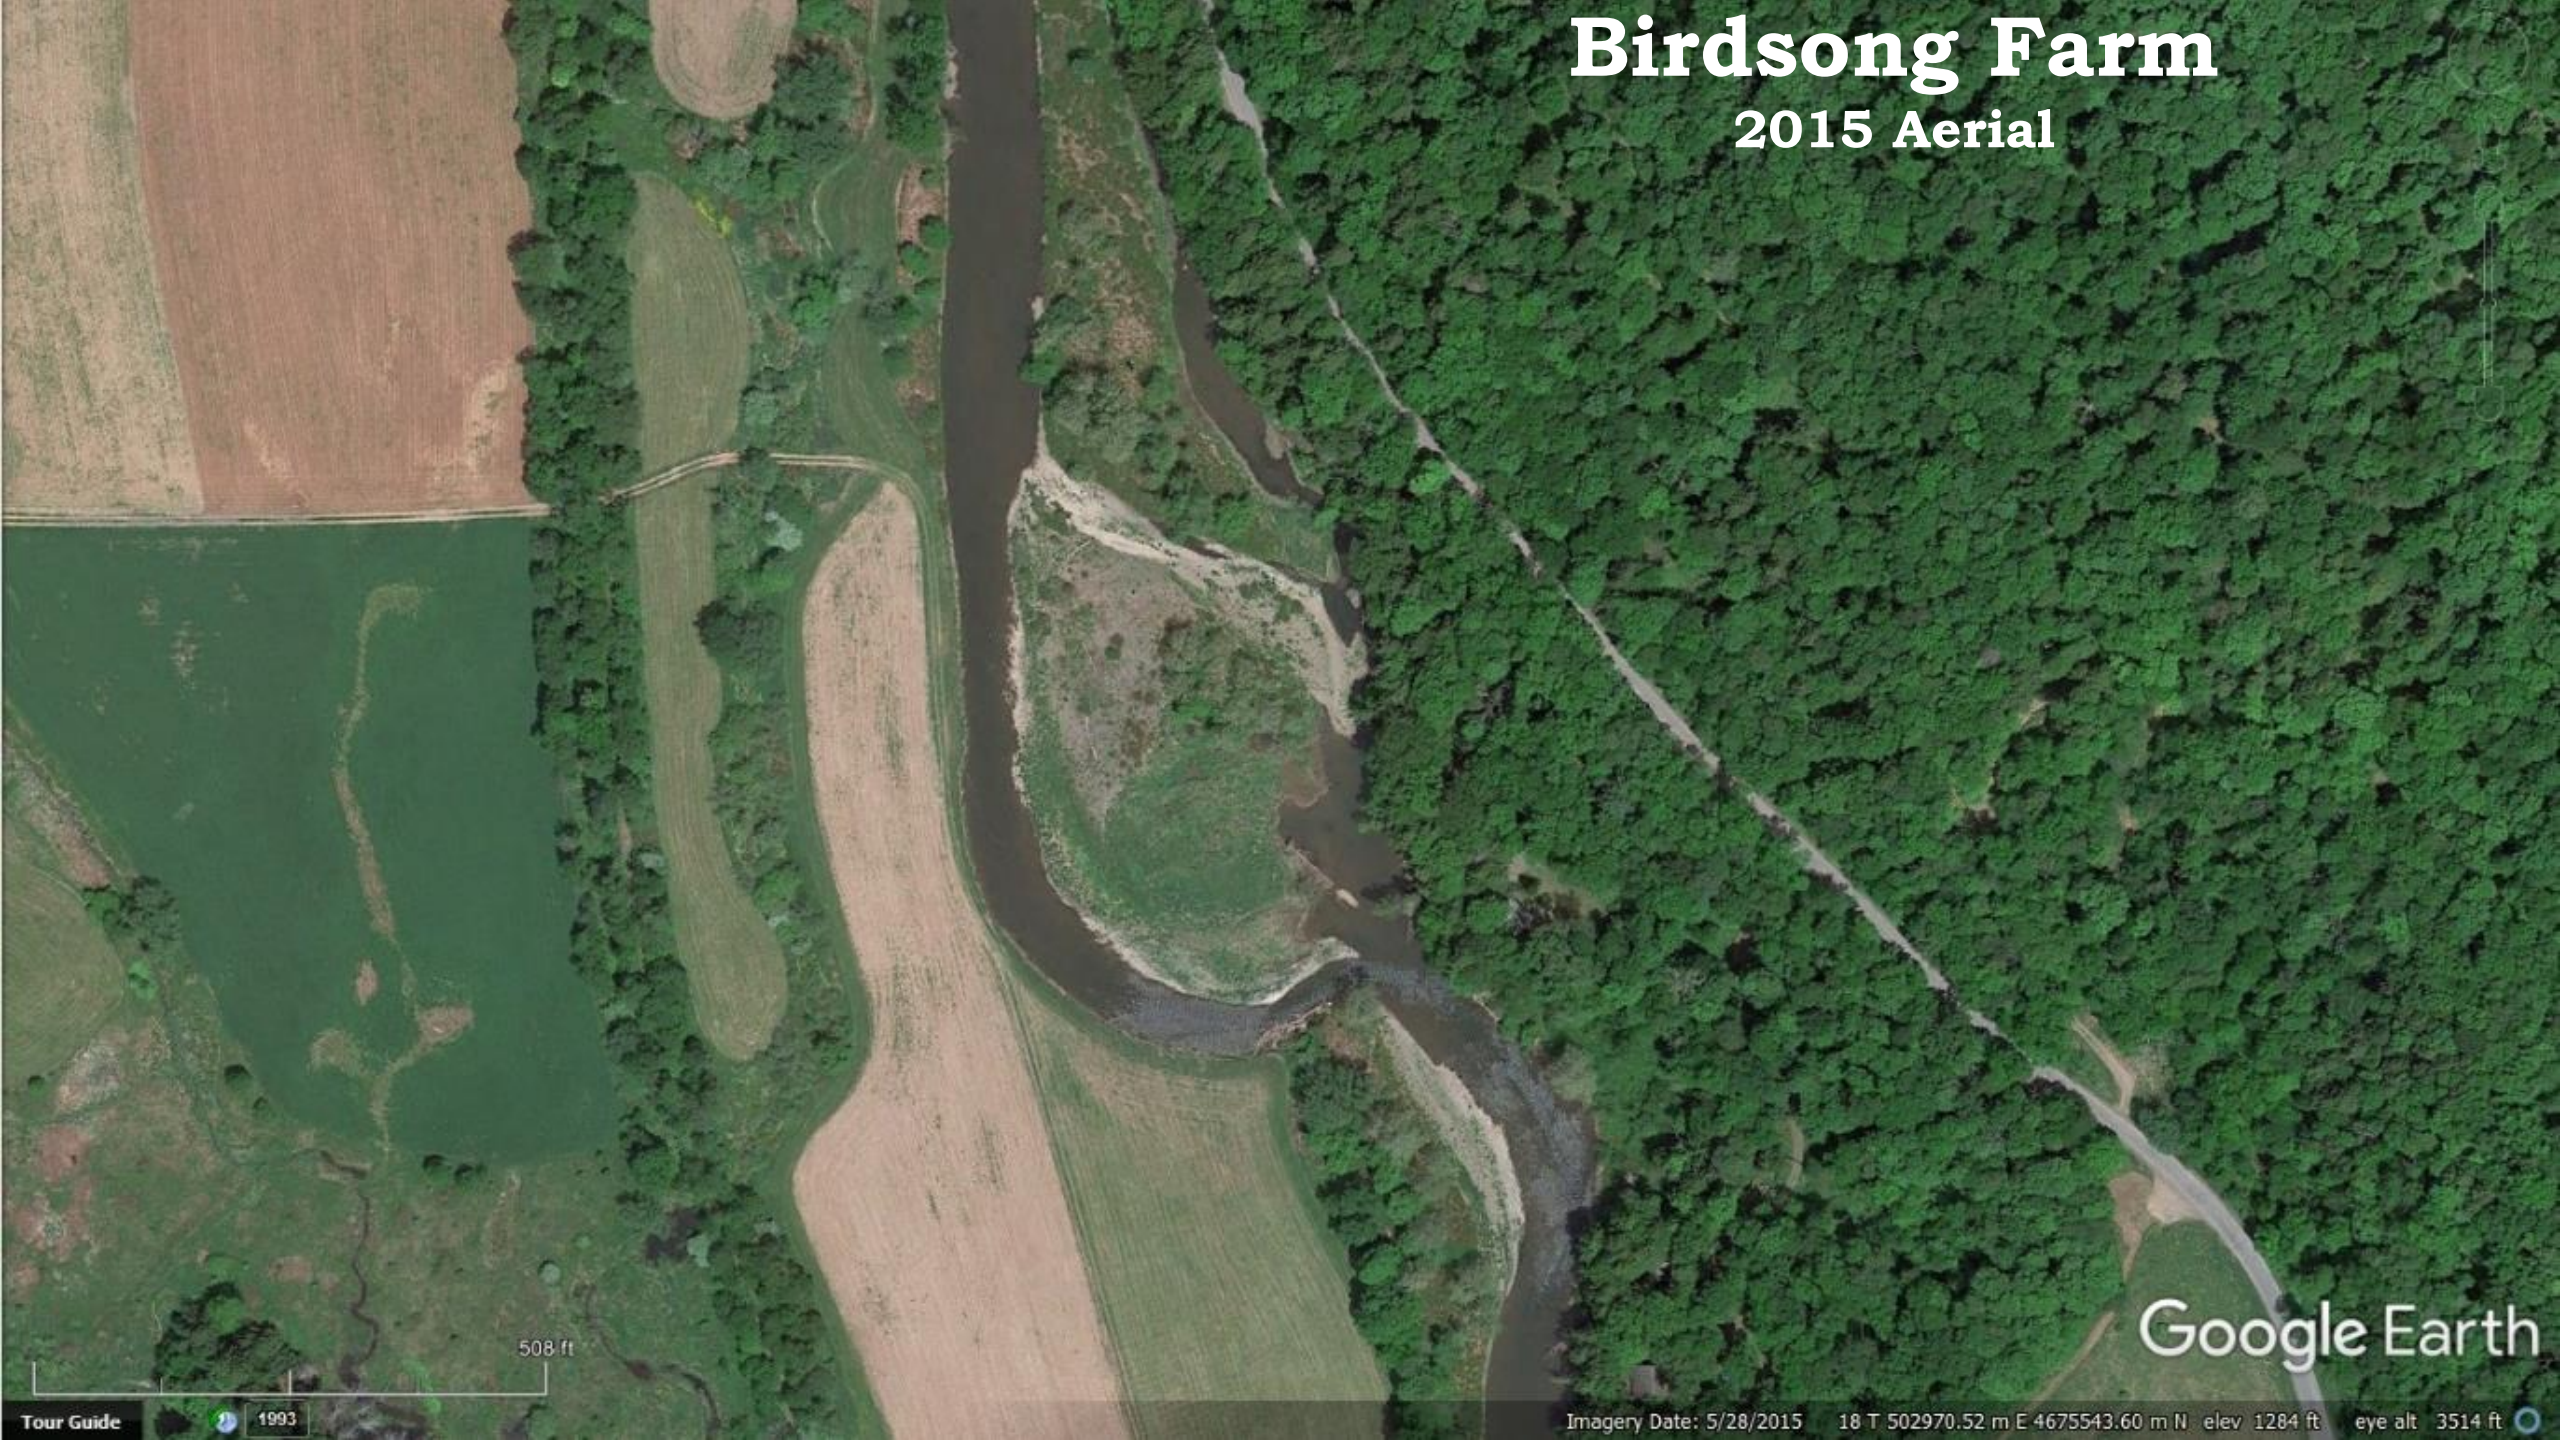
2015 Aerial

# Birdsong Farm

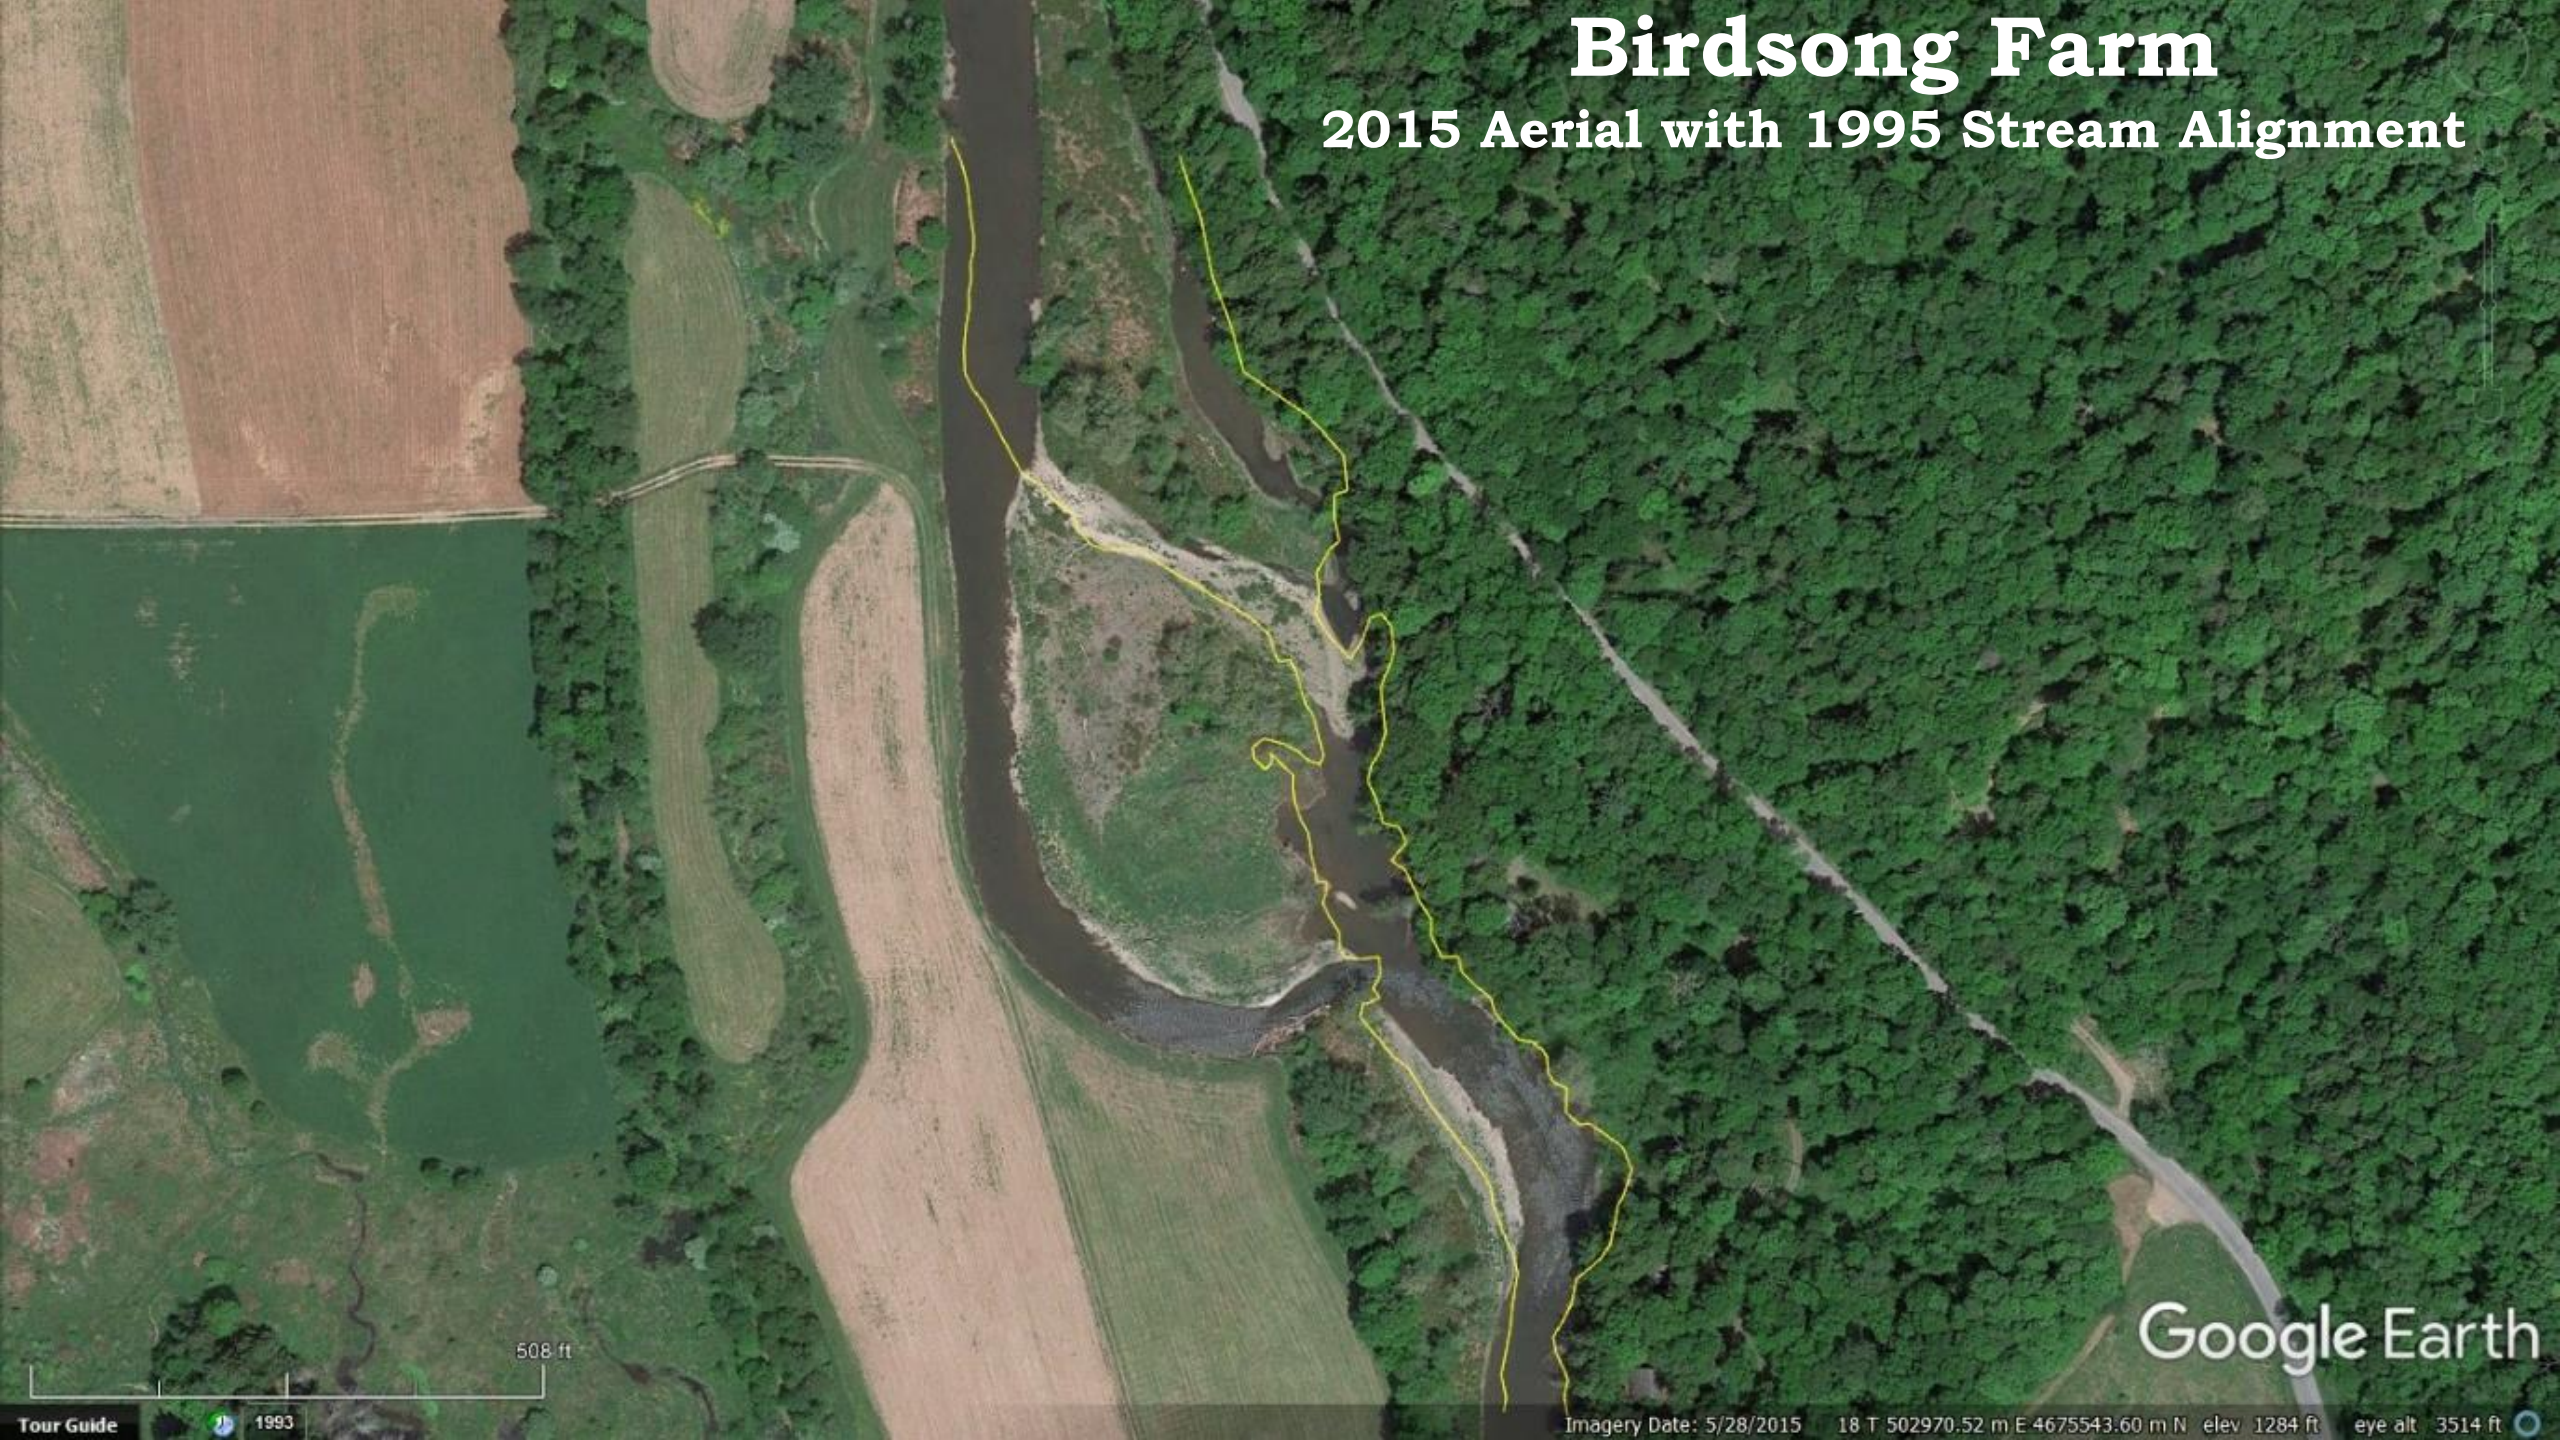
2015 Aerial with 1995 Stream Alignment

# Birdsong Farm

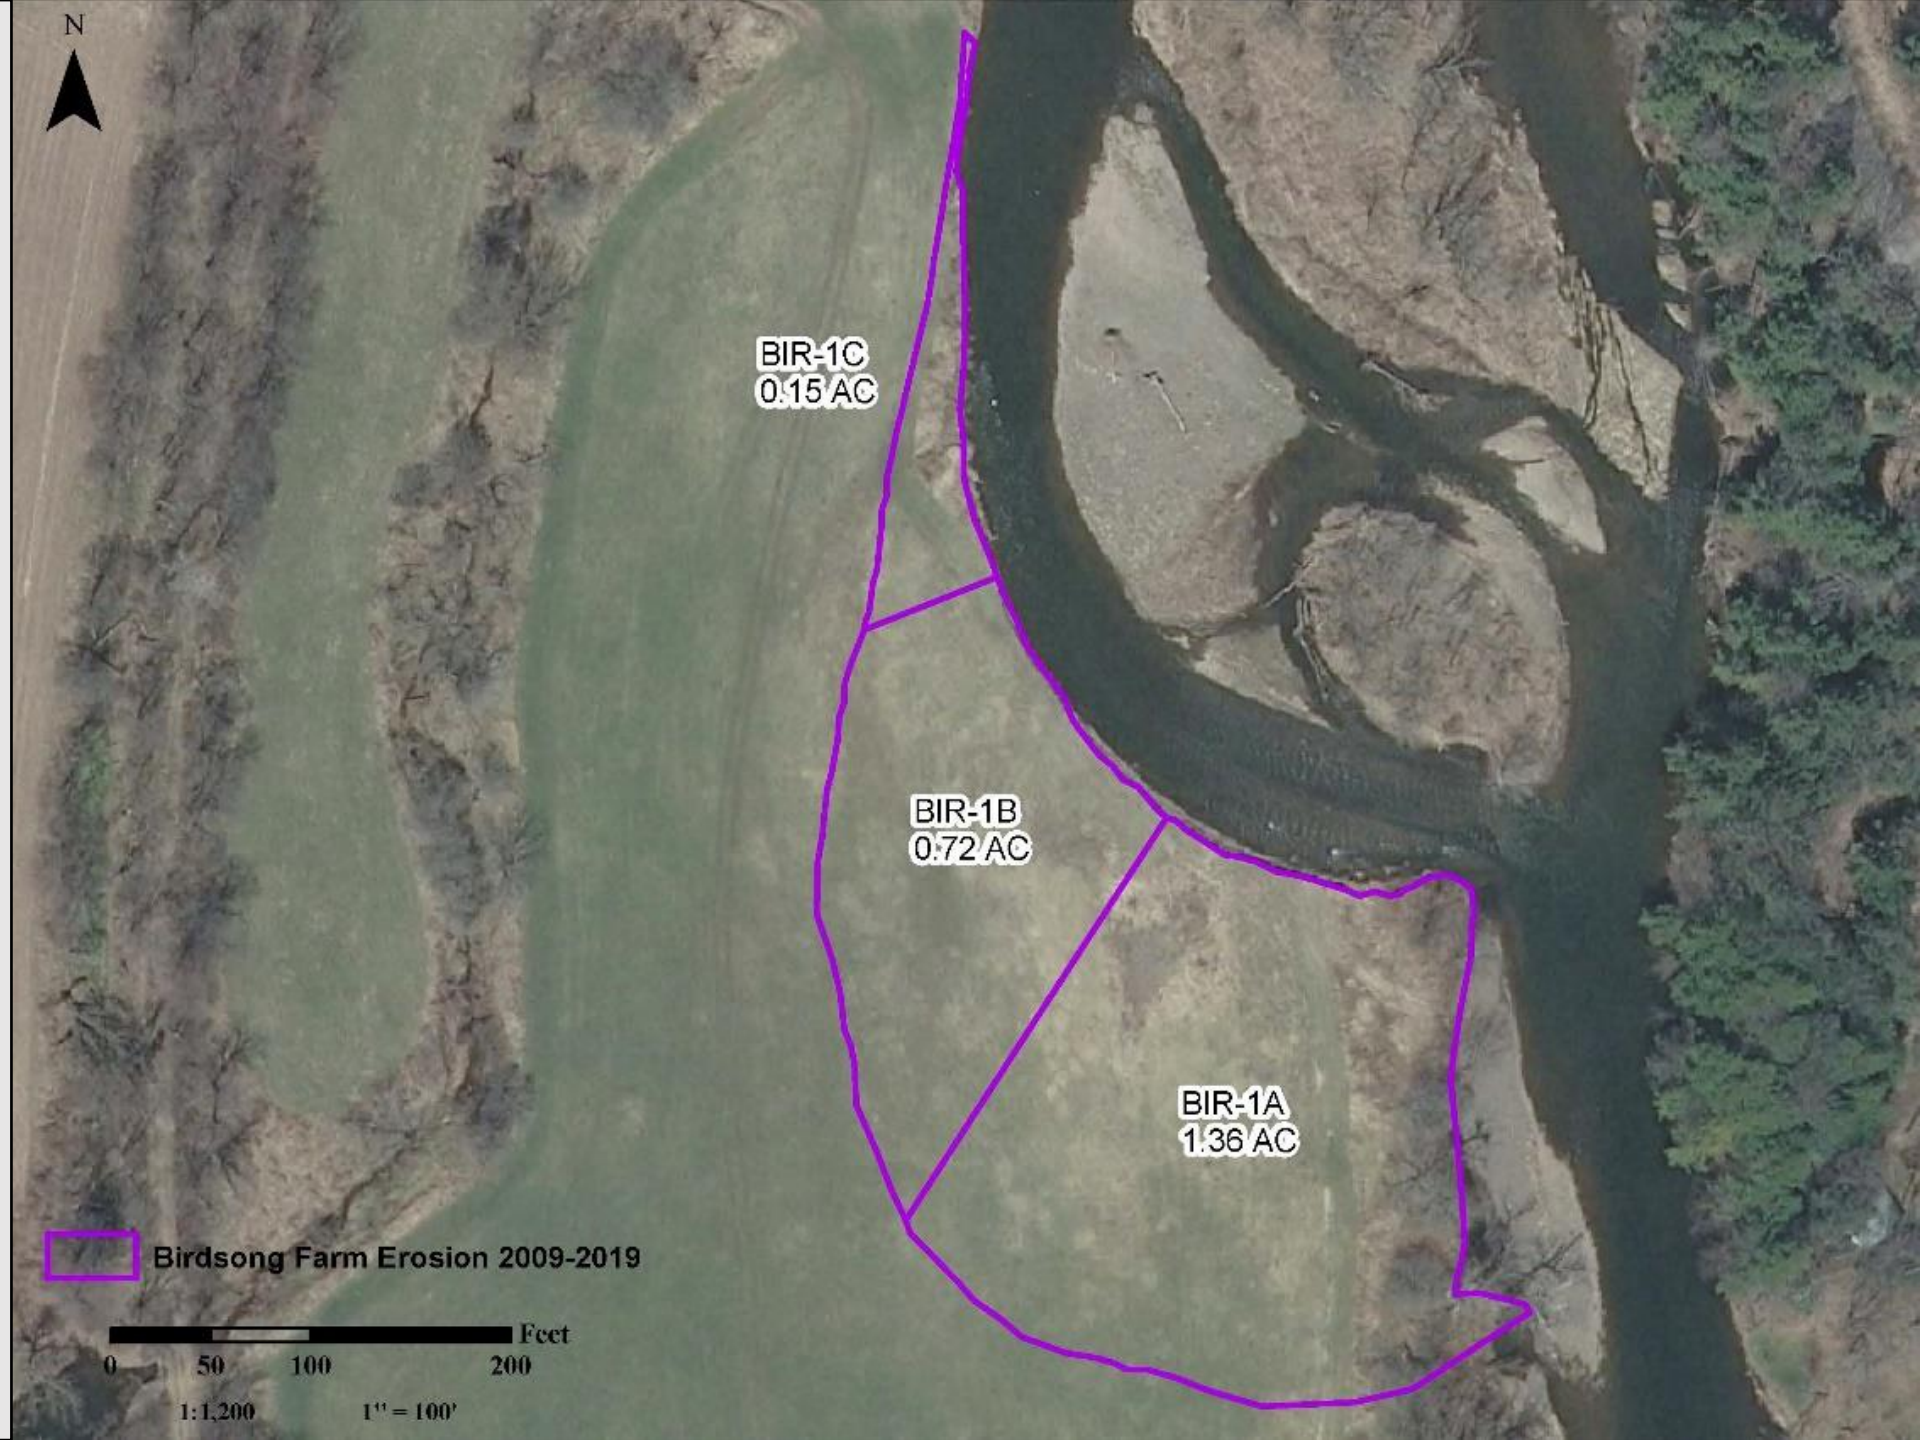
2009 Aerial

2.23 acres of Erosion  
from 2009-2019

Birdsong Farm Erosion 2009-2019

Location	Sediment (tons/yr)	Phosphorus (lb/yr)	Nitrogen (lb/yr)
Birdsong Farm	1,900	1,300	8,200

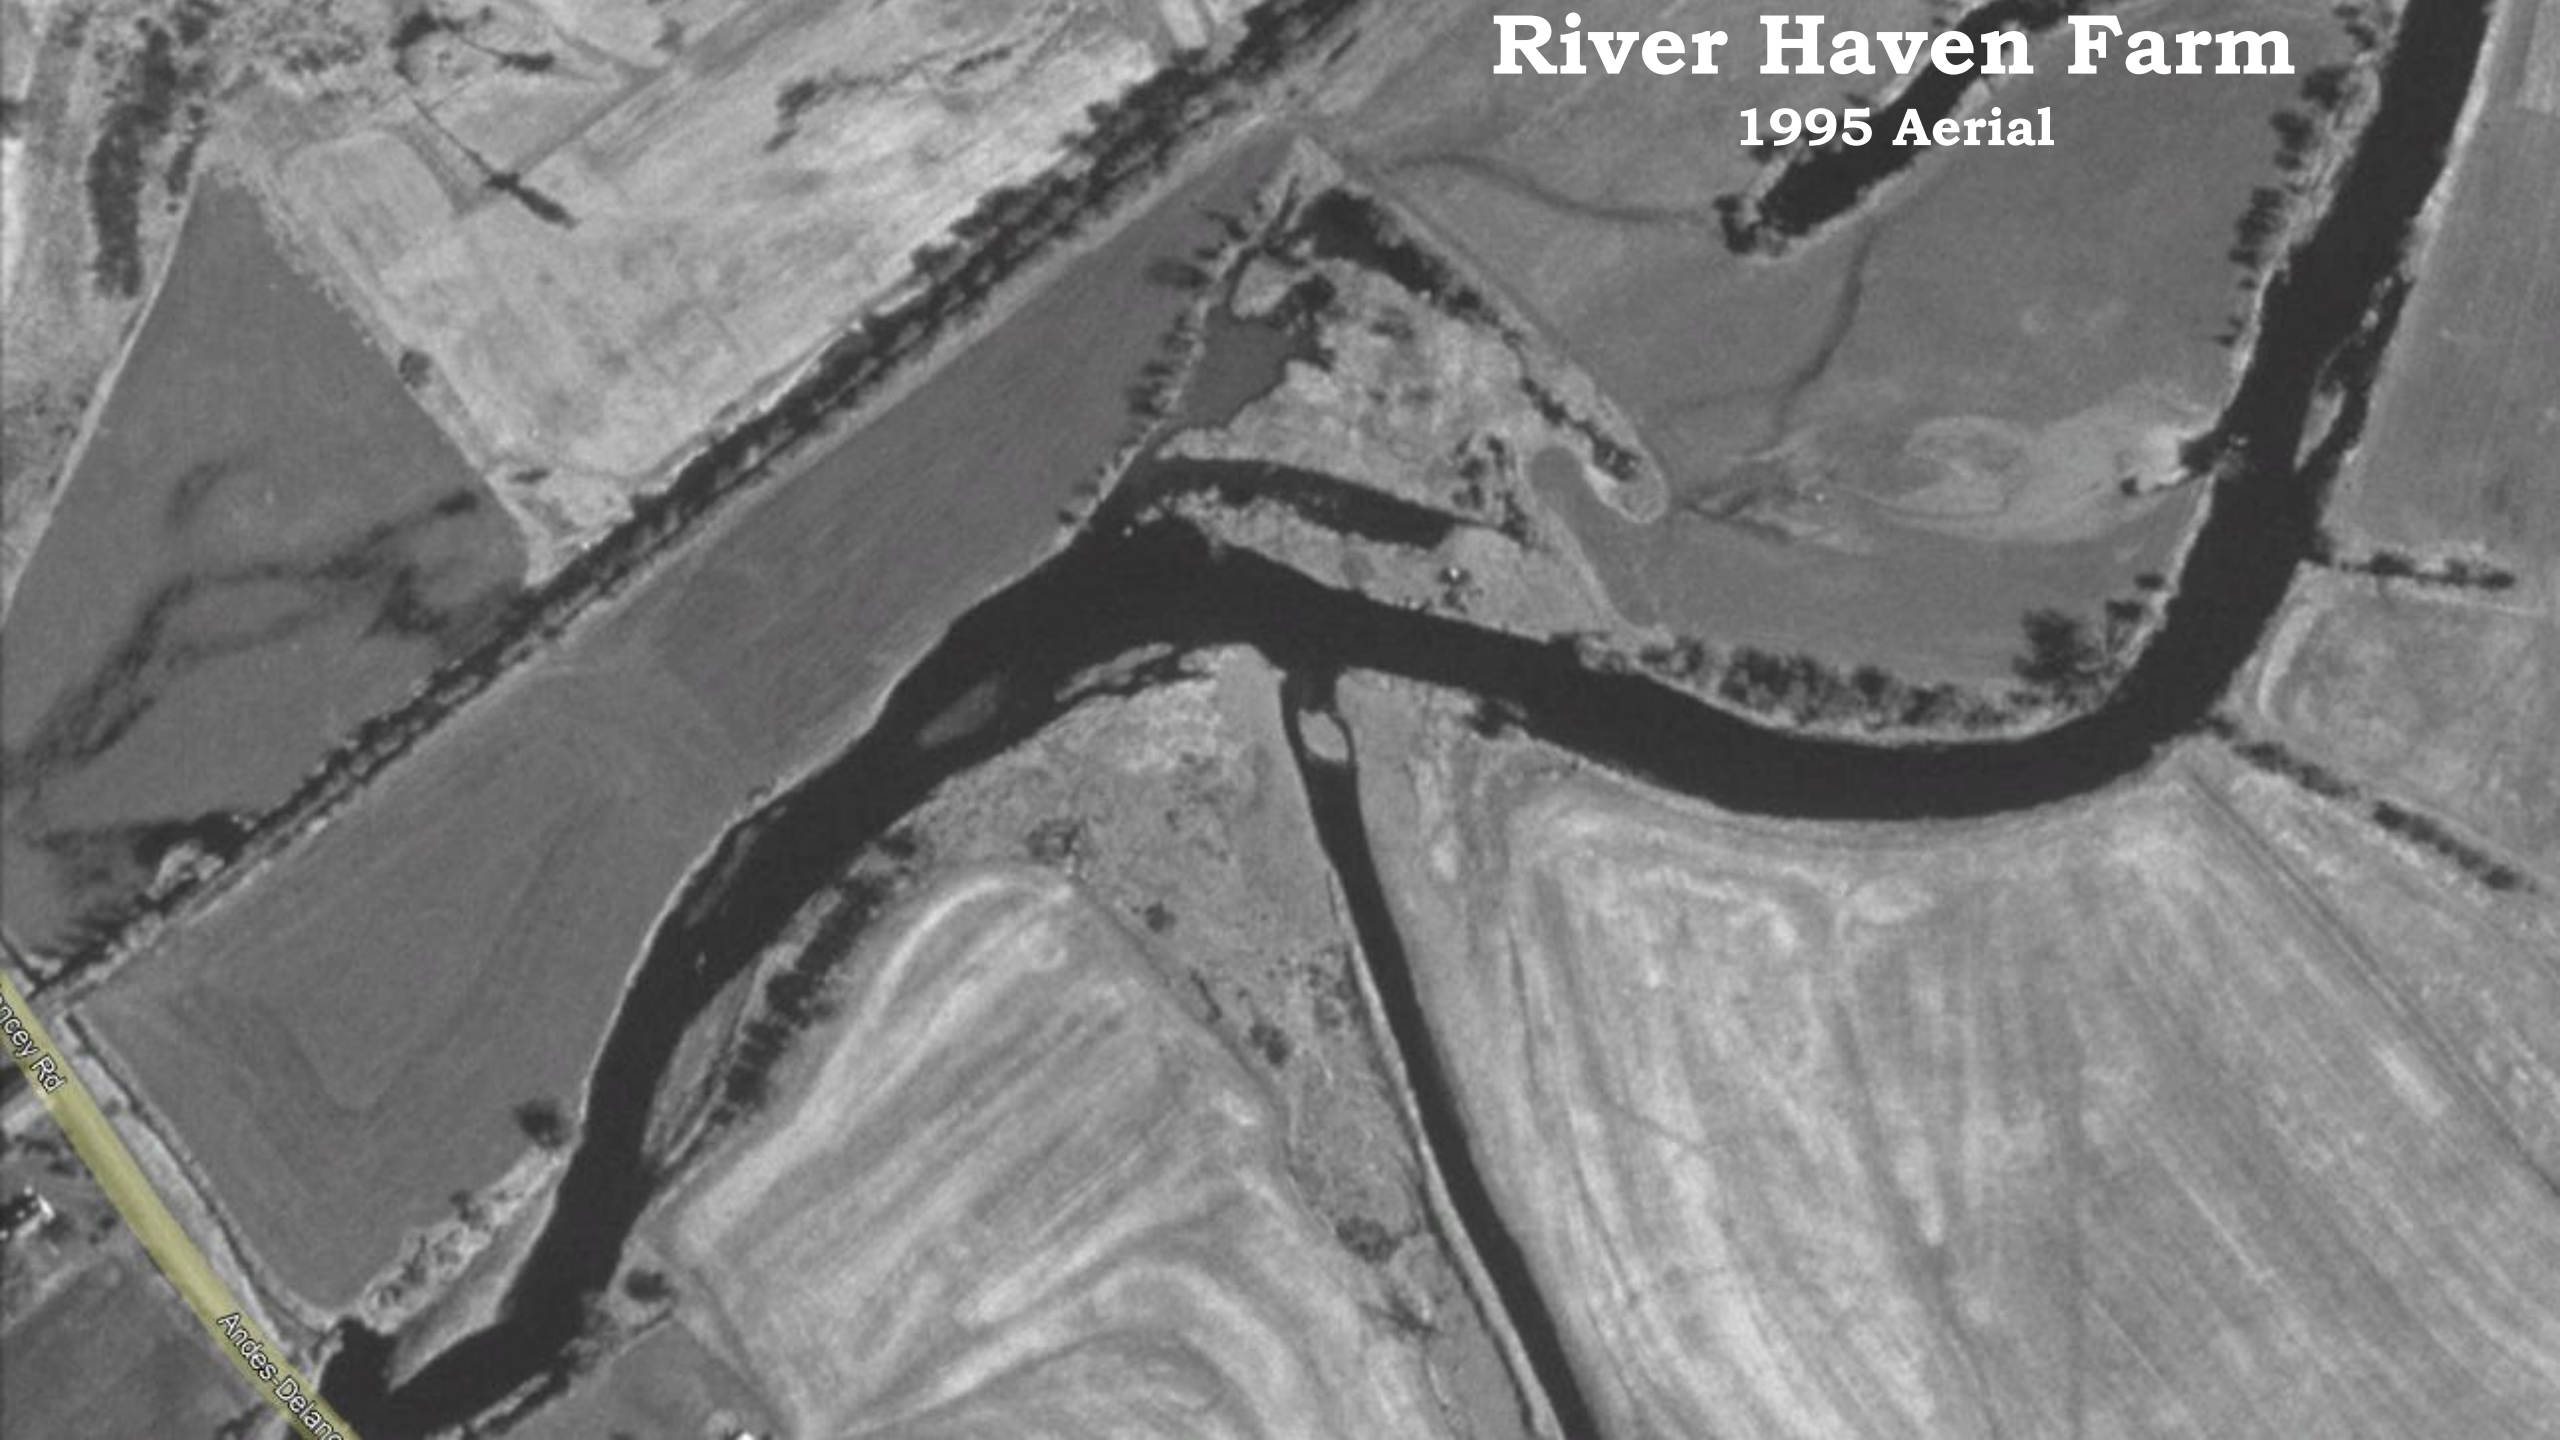
1995 Aerial

# River Haven Farm

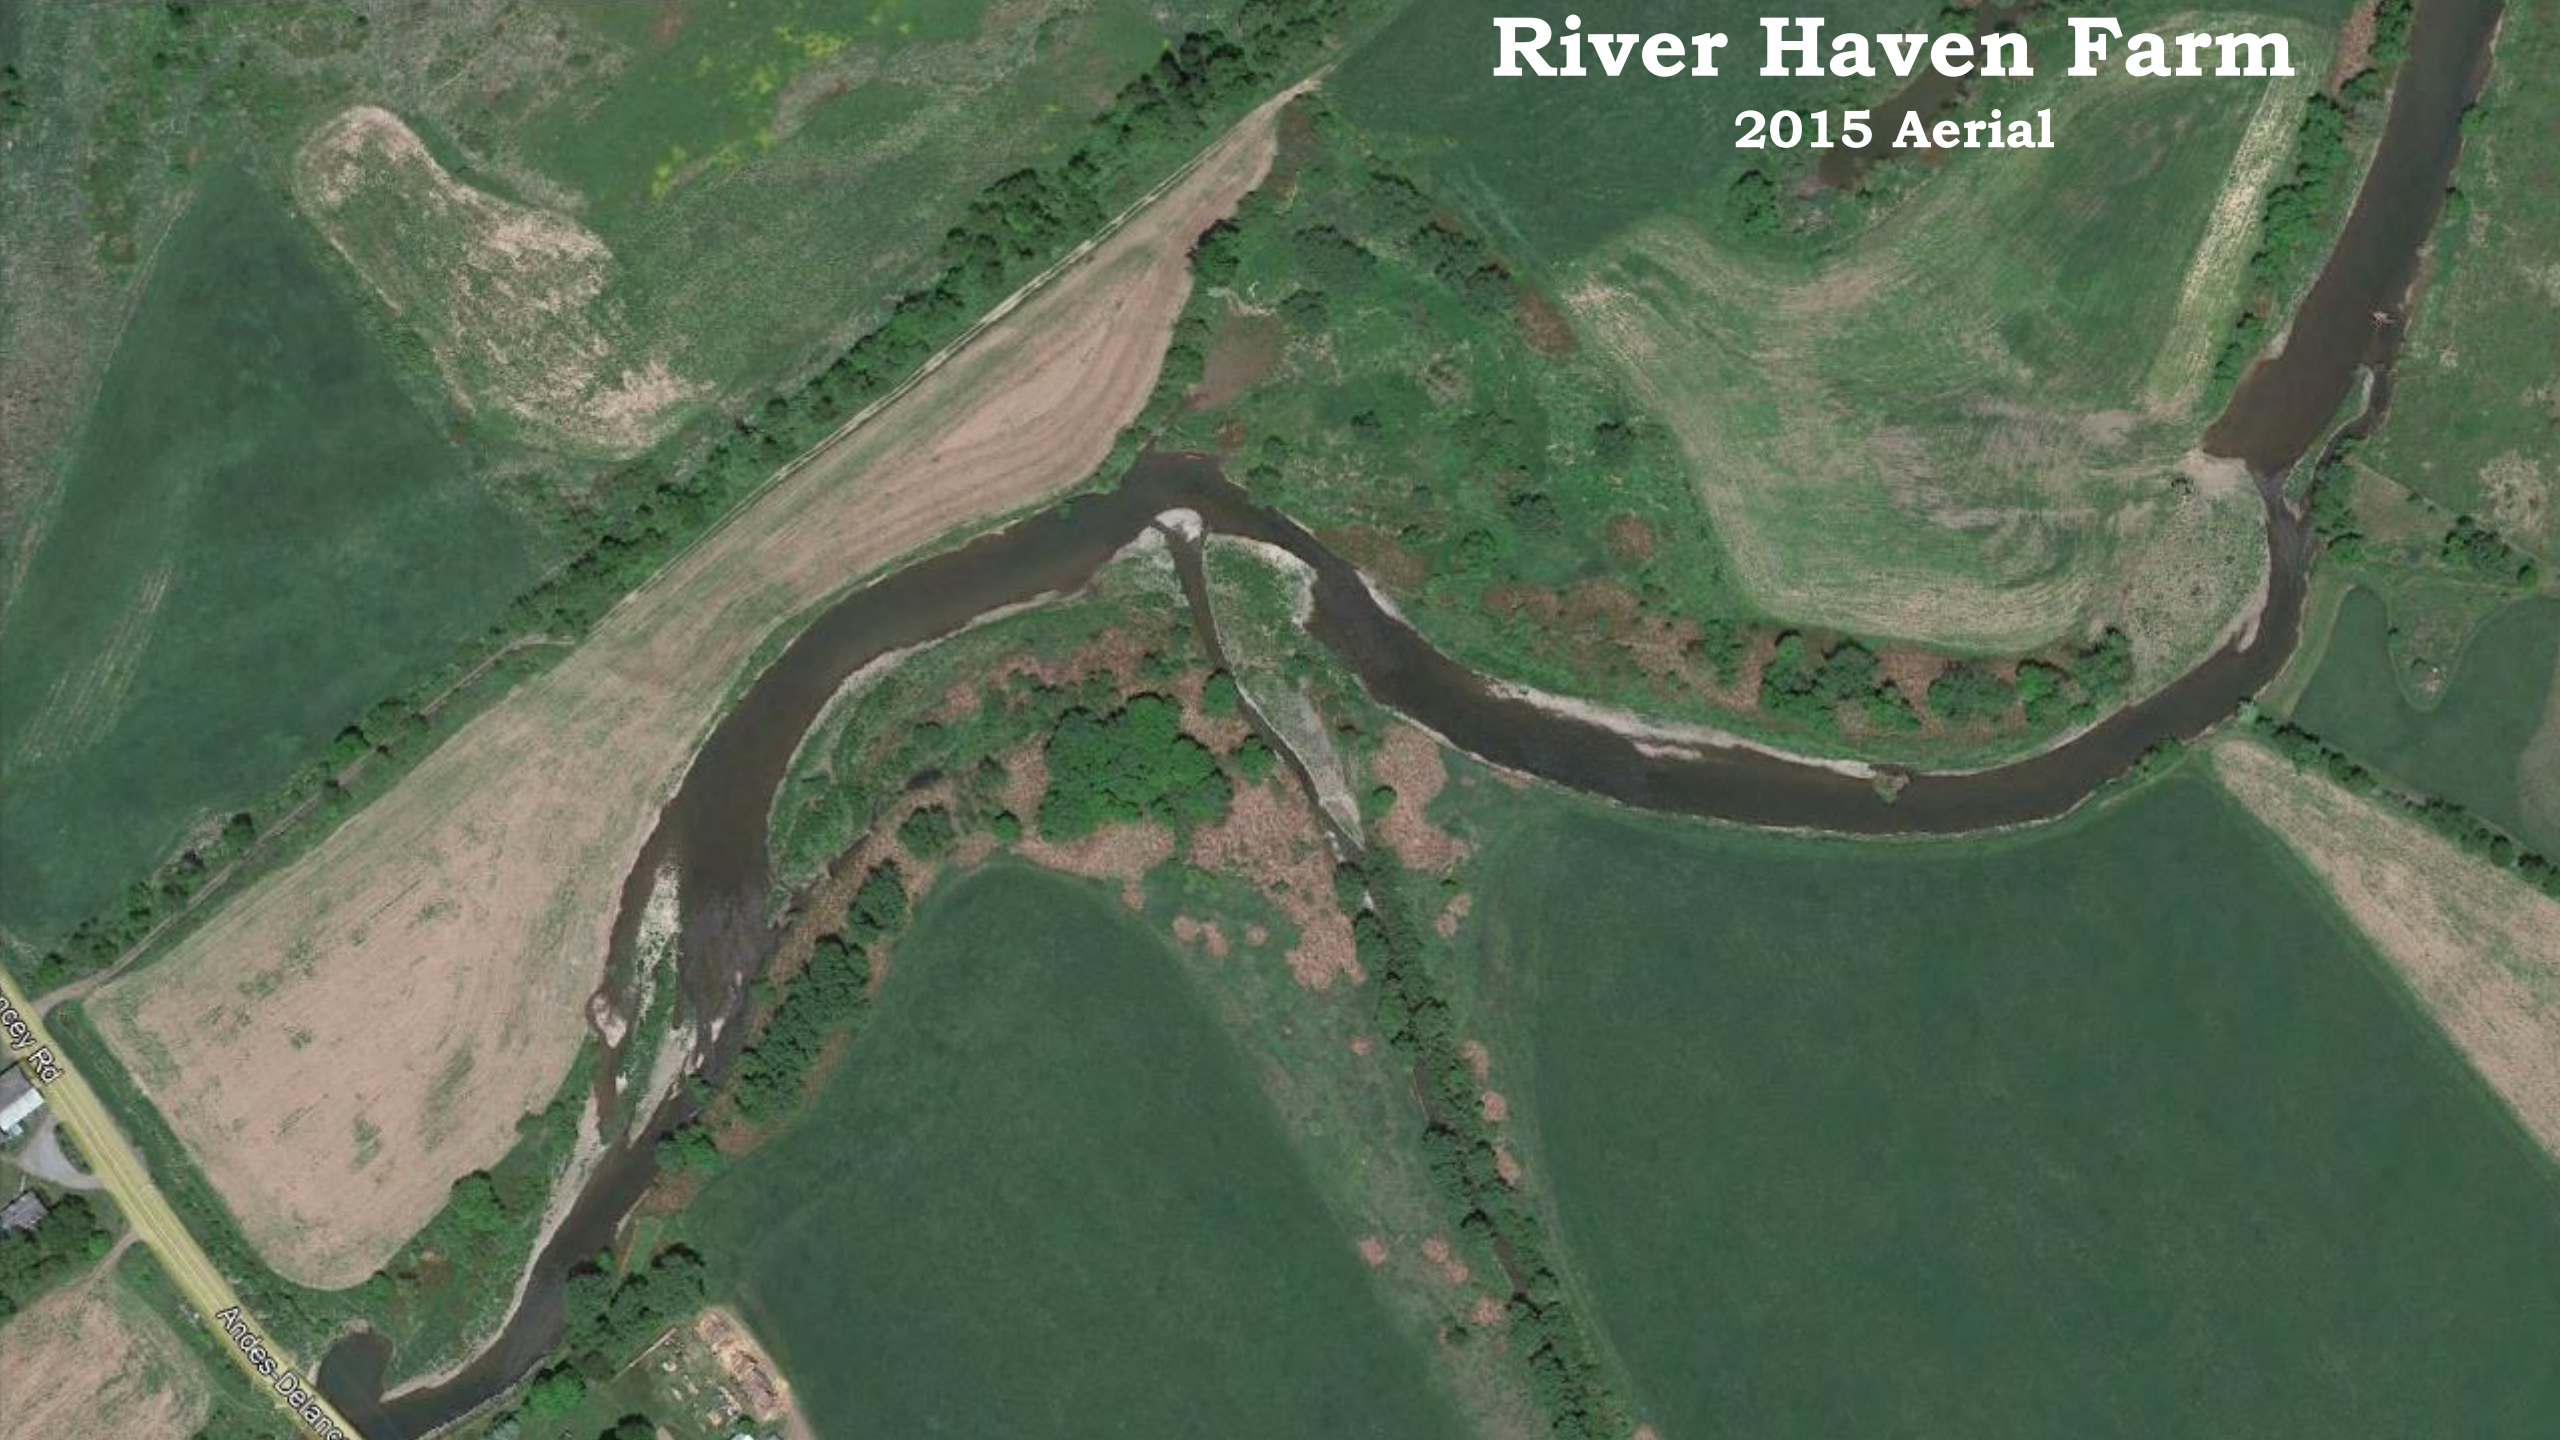
2015 Aerial

# River Haven Farm
