# **Nutrient Reduction Through Stream Restoration**

Graydon Dutcher  
Stream Program  
Delaware County Soil and Water Conservation District

**Estimating Nutrient Loads from Two Streambank Erosion Sites on  
the West Branch Delaware River, Delaware County, New York**

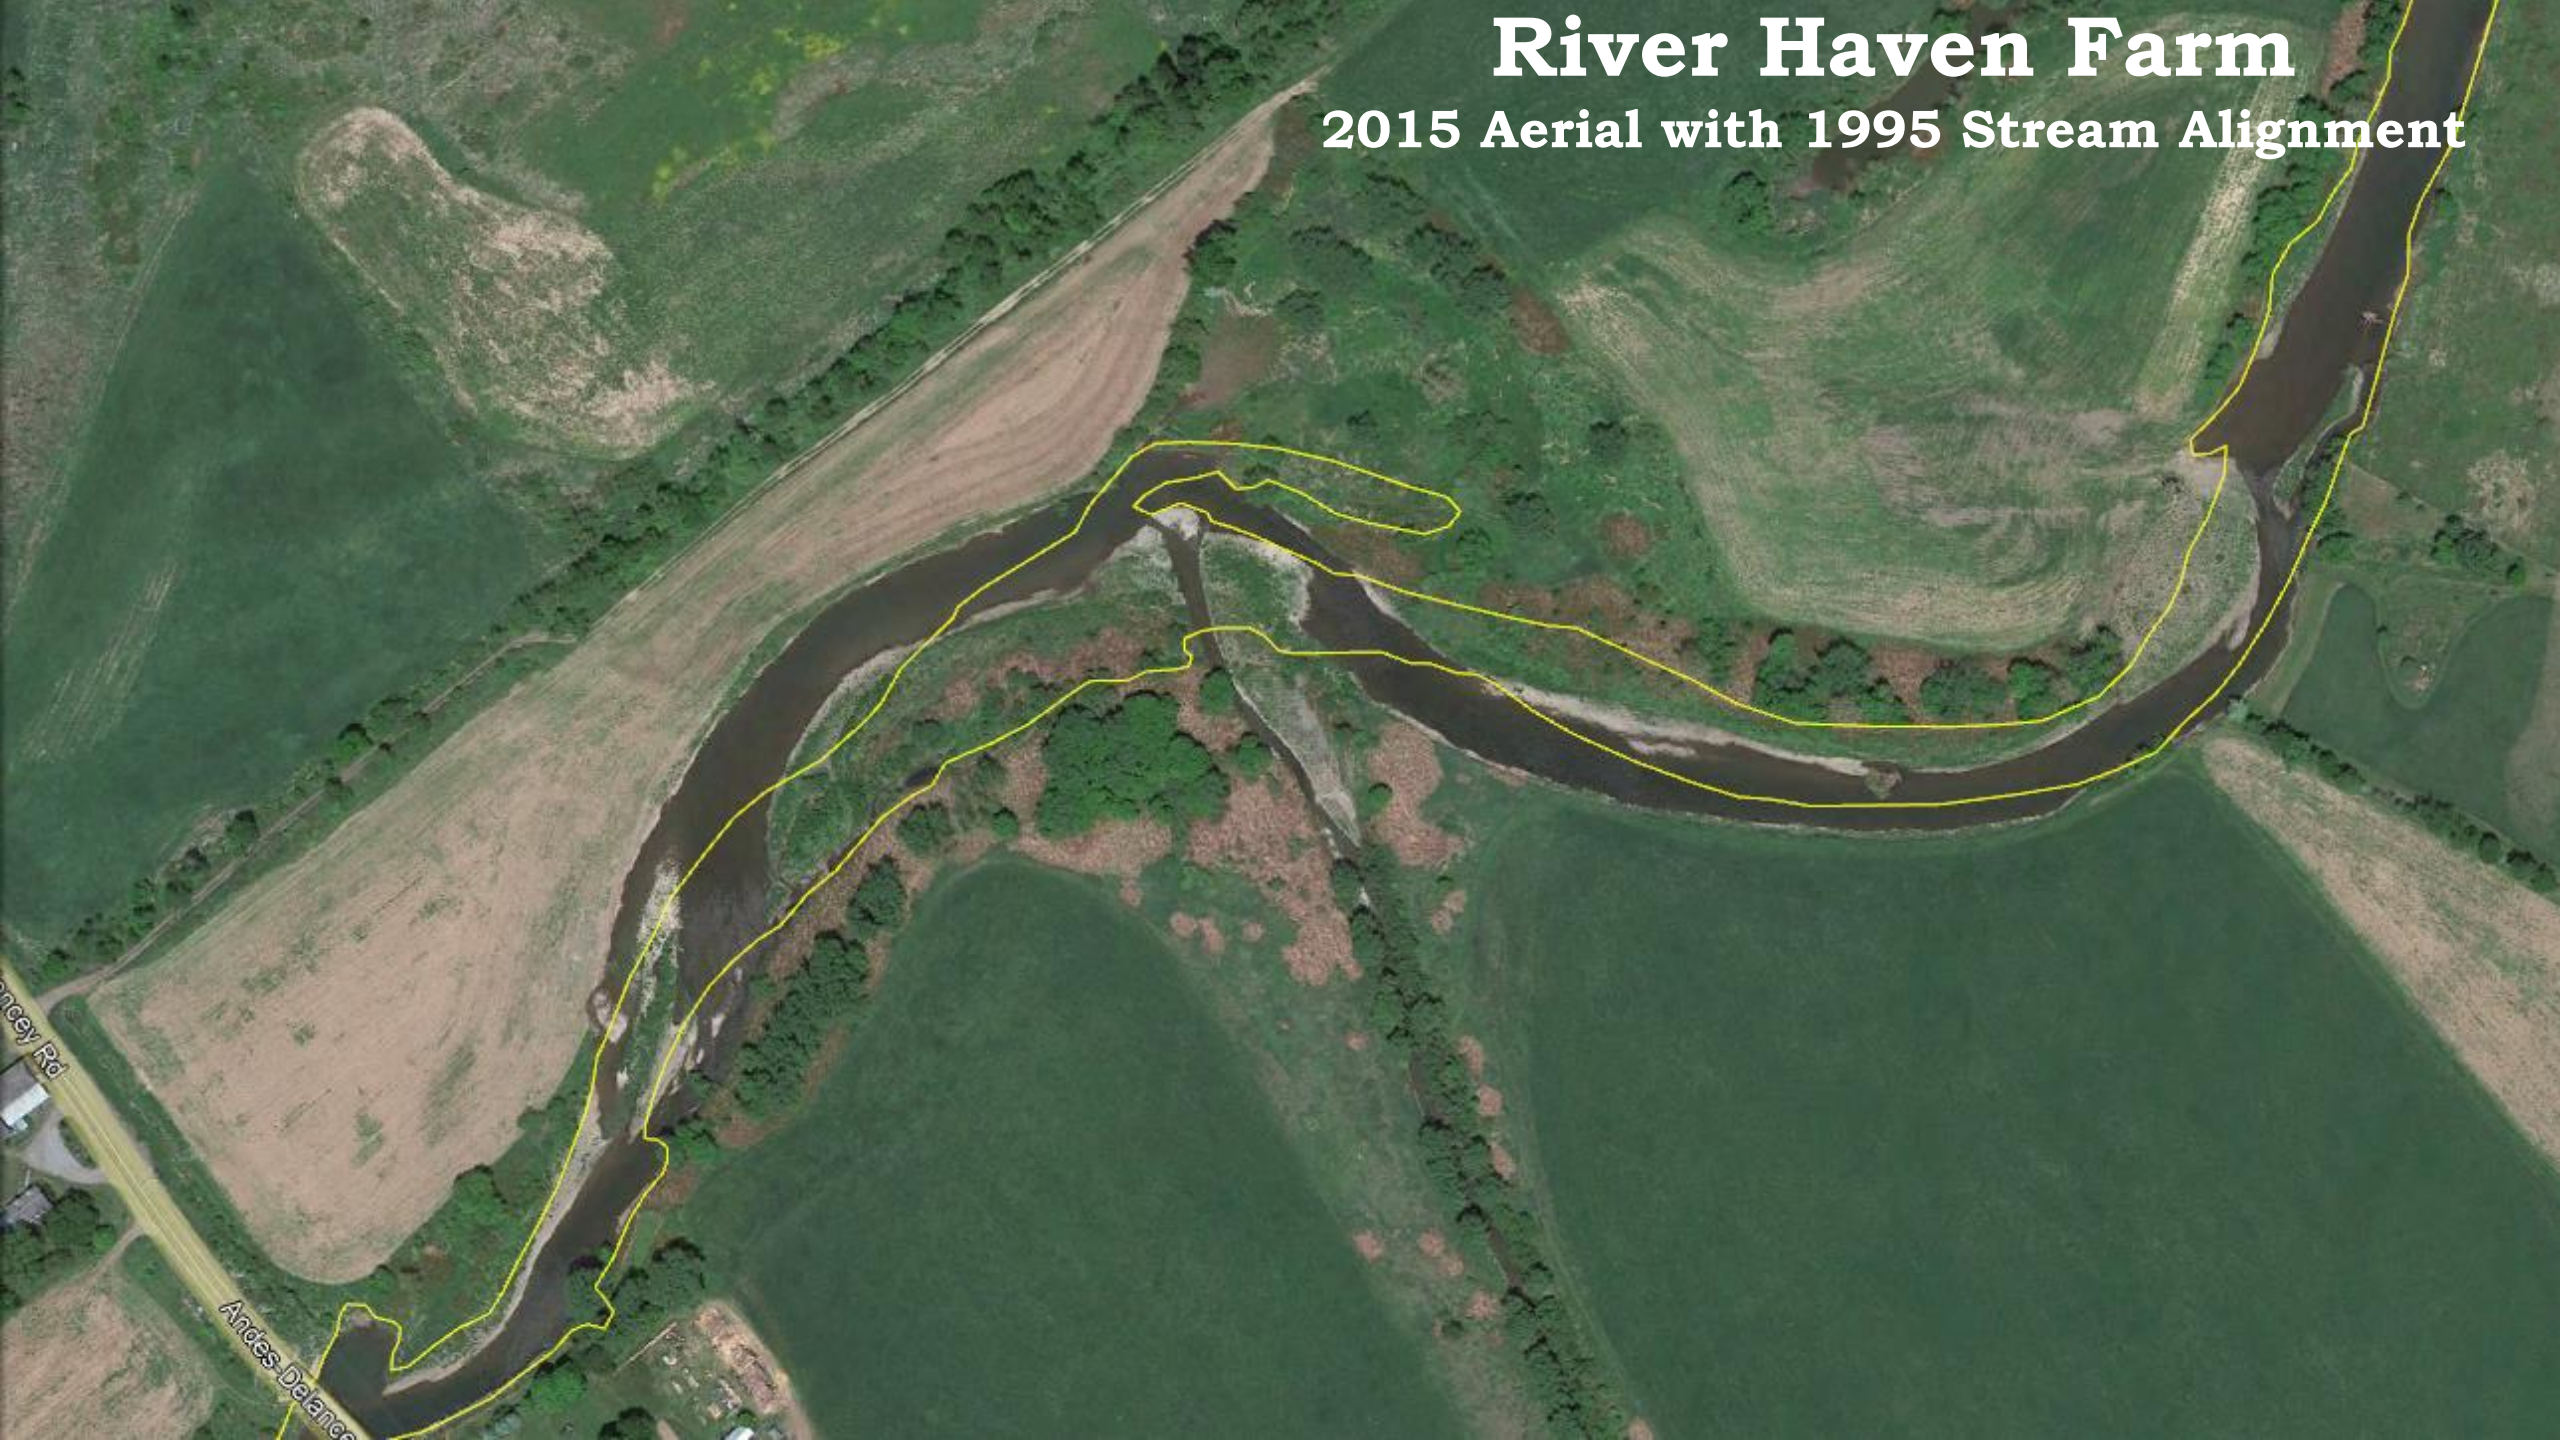
2015 Aerial with 1995 Stream Alignment

# River Haven Farm

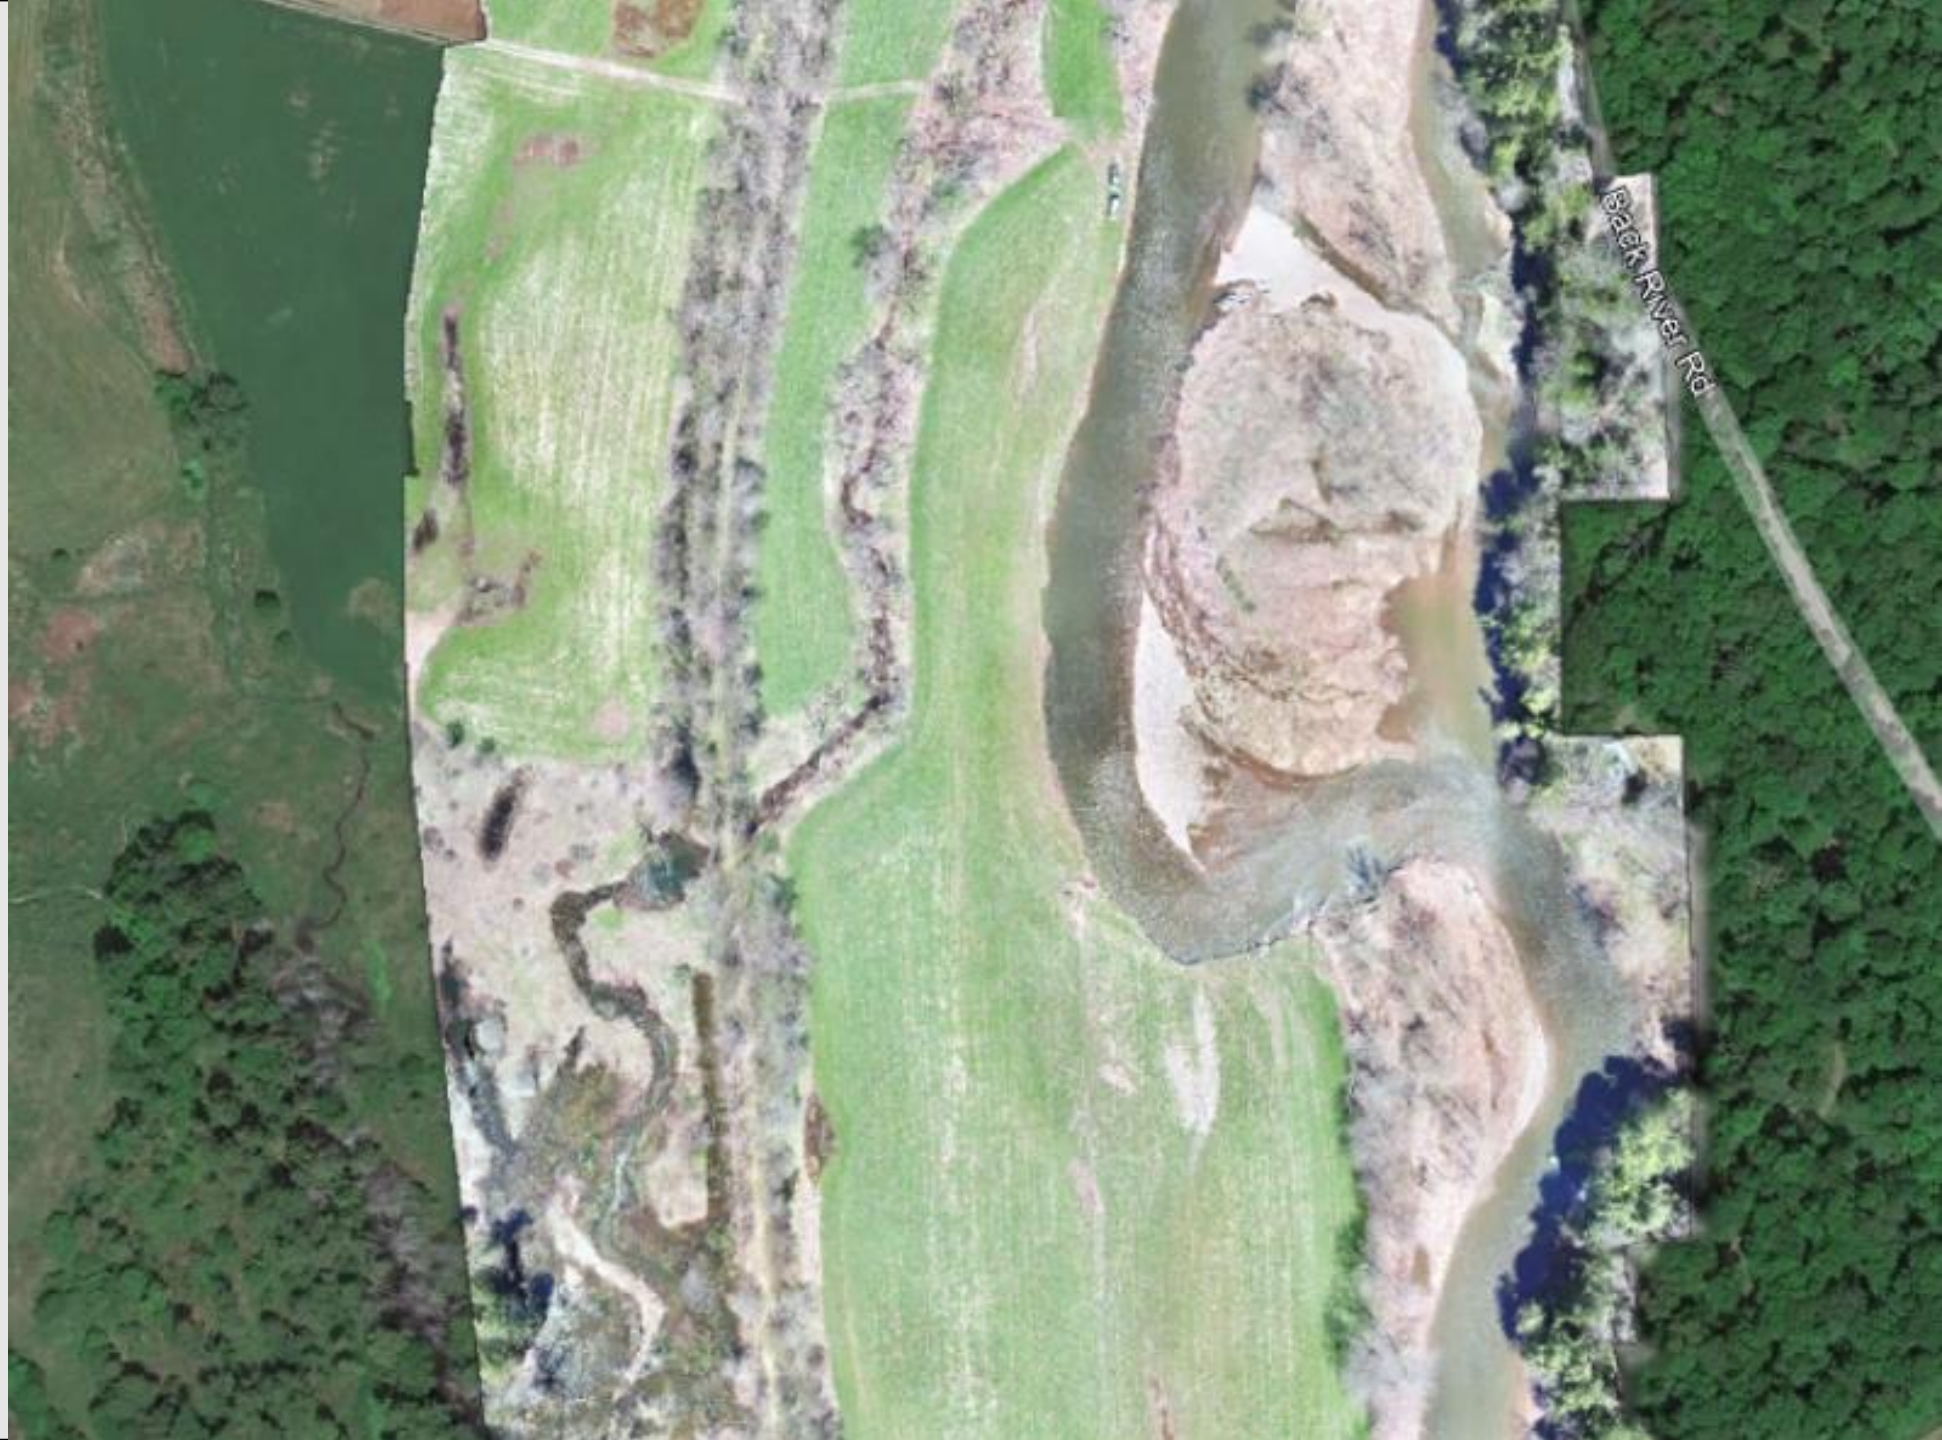
Preliminary Design

# **Birdsong Farm**

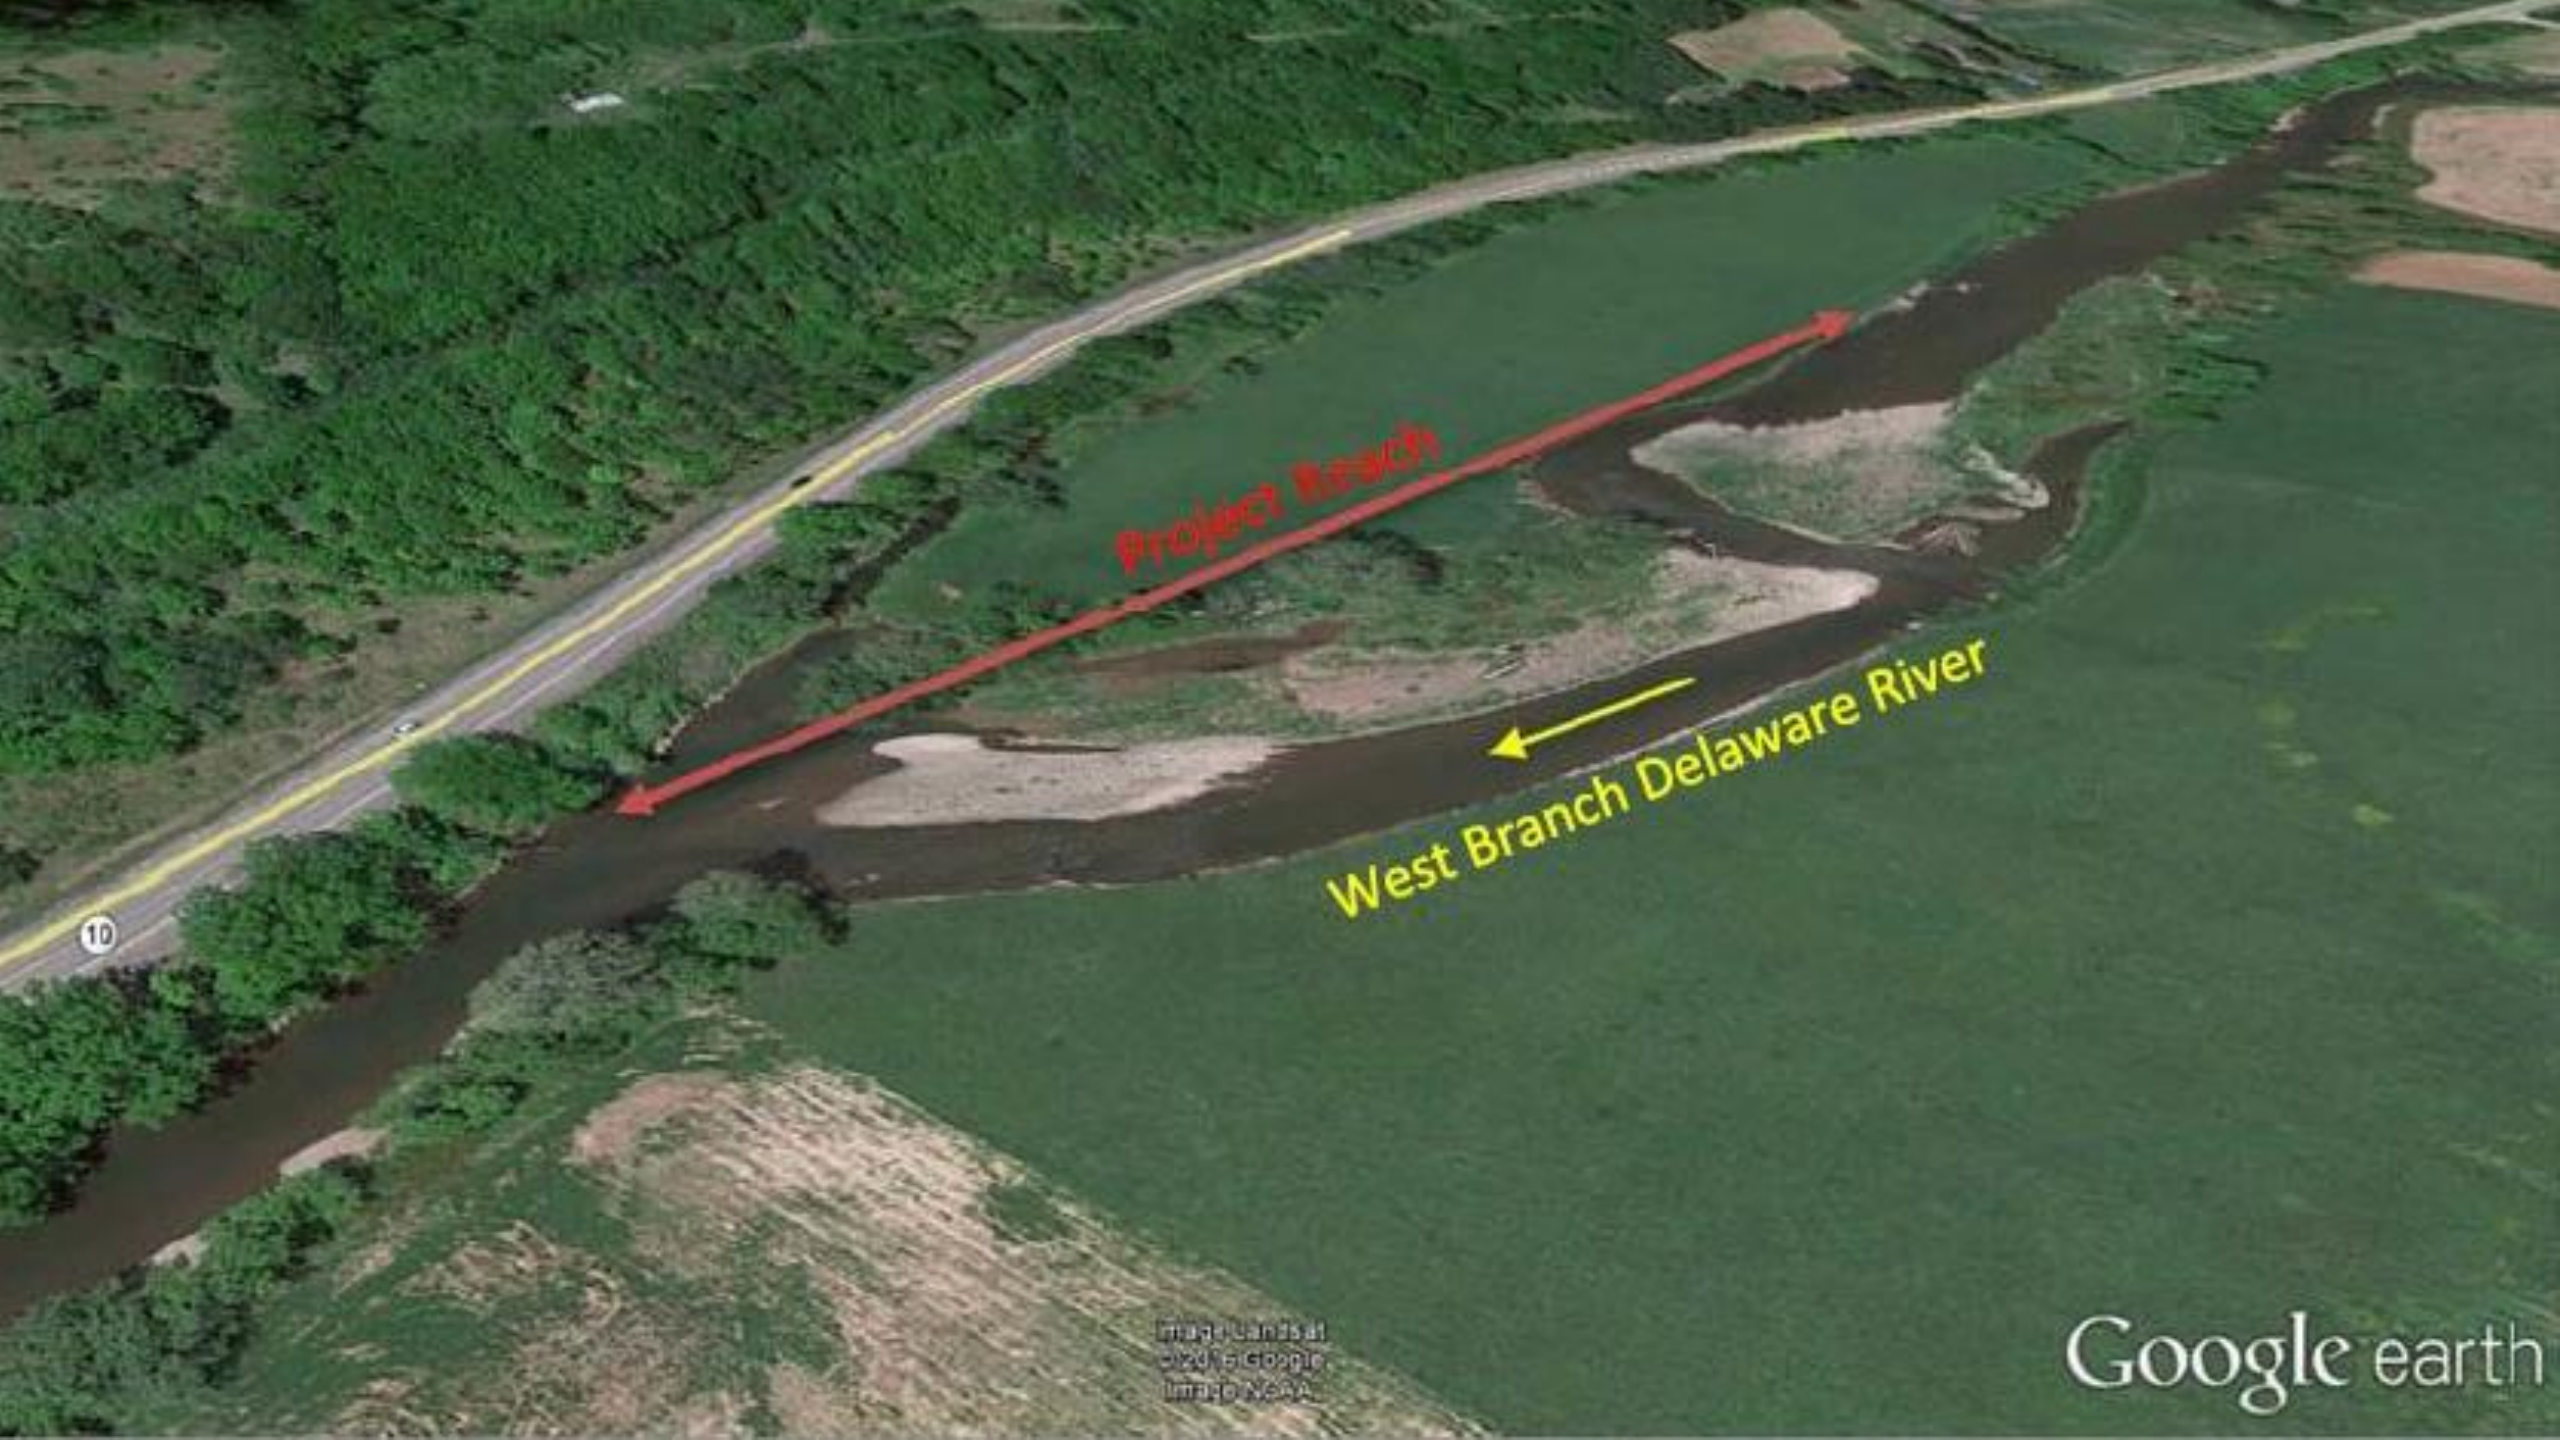
# **More Streambank Stabilization Project**

Project Reach

Location	Sediment (tons/yr)	Phosphorus (lb/yr)	Nitrogen (lb/yr)
More Farm	1,900	390	730
